# CENTRAL OF GEORGIA RAILWAY VIADUCT ASSESSMENT

Inspection Date: April 14, 2020  
Submittal Date: May 8, 2020

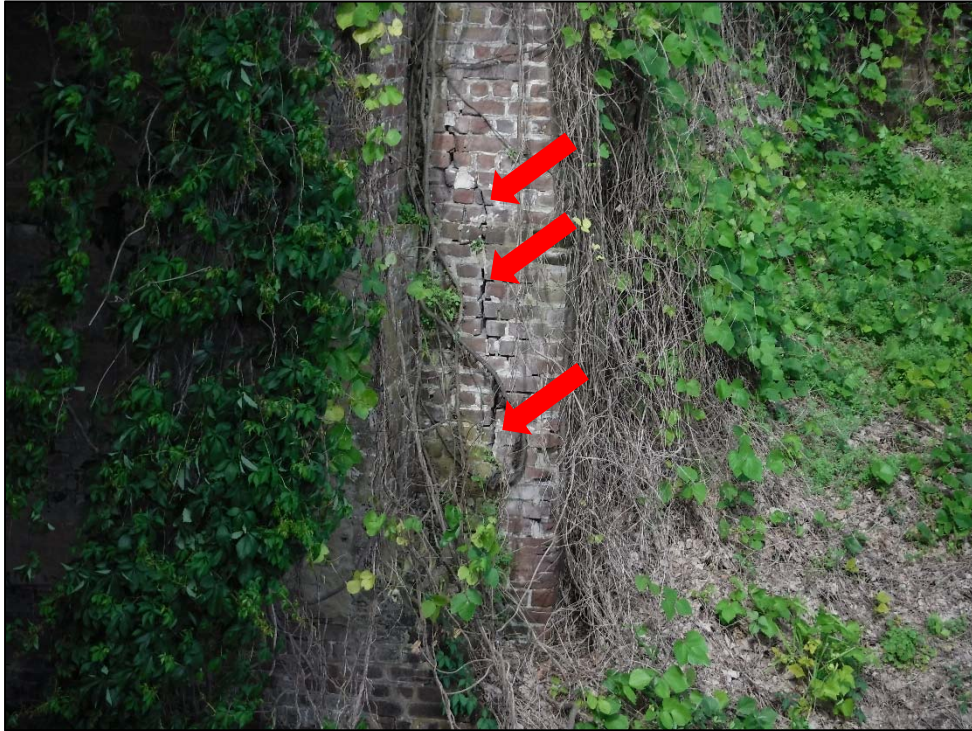
- A crack up to 3/4-in wide initiated from the buildout west of Arch 1 and propagated into the arch; see Section 2.4 for additional information. Approximately fifteen damaged bricks were observed at the buildout. (Photograph 25)

Photograph 25 – Brick Masonry Crack in Arch 1

- 
17. Cracks in the brick masonry which do not exhibit differential displacement should be re-pointed. The repair mortar should match the existing in appearance, color, composition, and historic character. All damaged bricks in the vicinity of any crack should be removed and replaced with brick that matches the existing in appearance, color, size, composition, and historic character. A maximum joint width of 1/2-in should be provided when reconstructing areas of brick. Stainless steel helical “stitching” rods should be installed within the horizontal mortar joints across cracks as determined by the Engineer of Record.

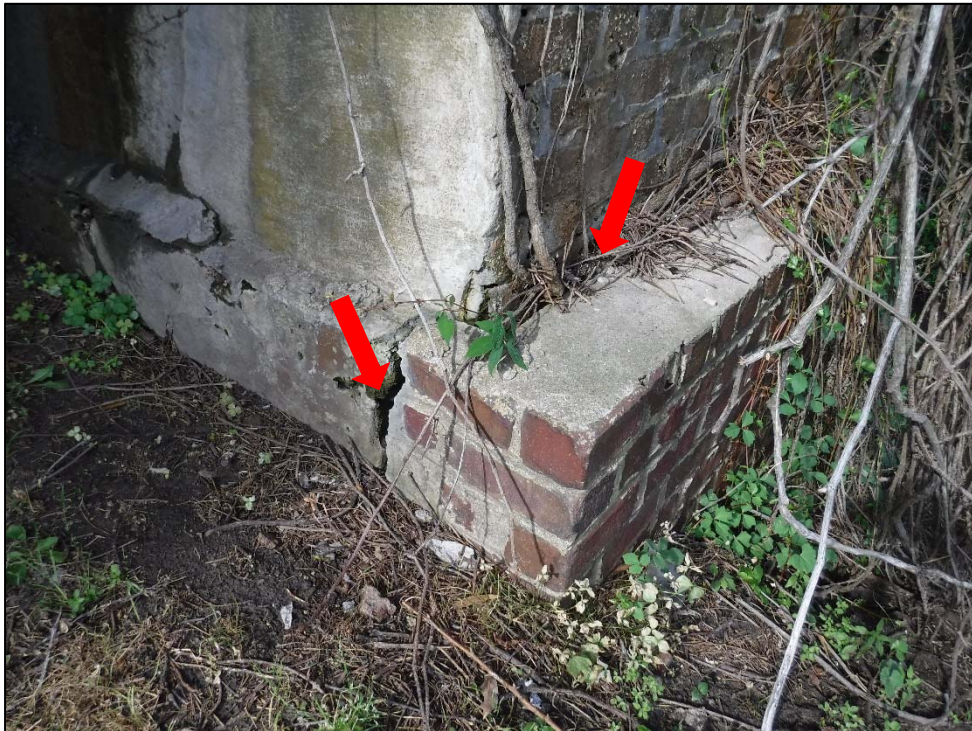
- An approximately 3-ft long portion of brick has separated up to 1-in from the base of the northwest corner of Pier 1. The brick appears to have displaced due to vegetation growth. (Photograph 26)

Photograph 26 – Separation and Displaced Brick with Vegetation at Pier 1

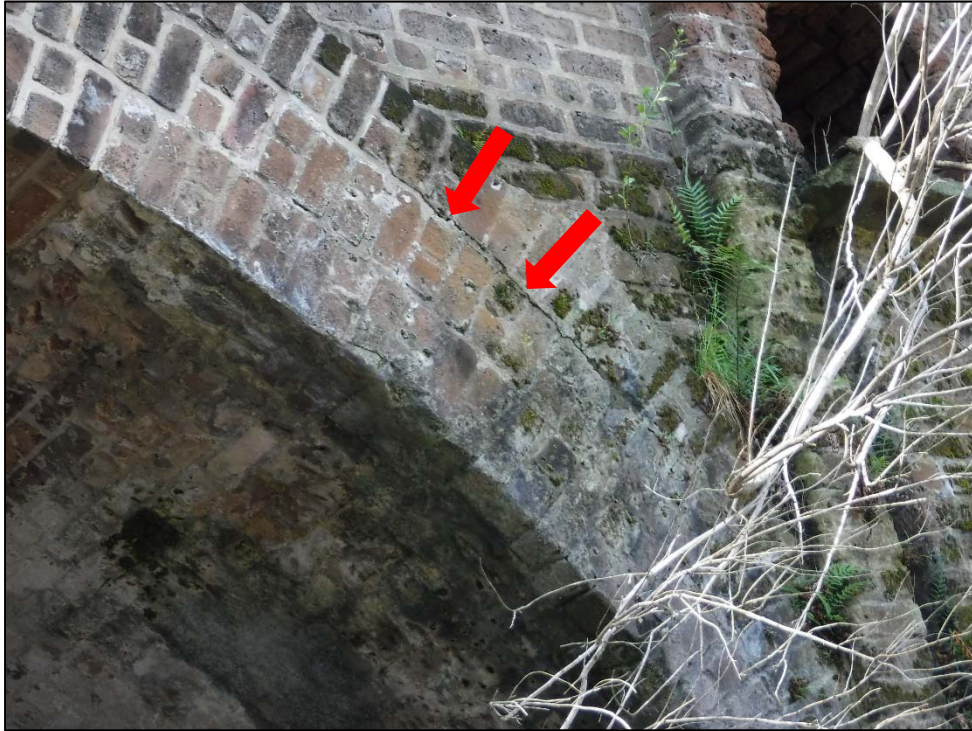
- A crack up to 1/8-in wide by 24-in long was observed between the second and third major courses of the masonry arch ring at the southeast corner of Arch 4. (Photograph 27)

Photograph 27 – Crack in Masonry Arch Ring in Arch 4

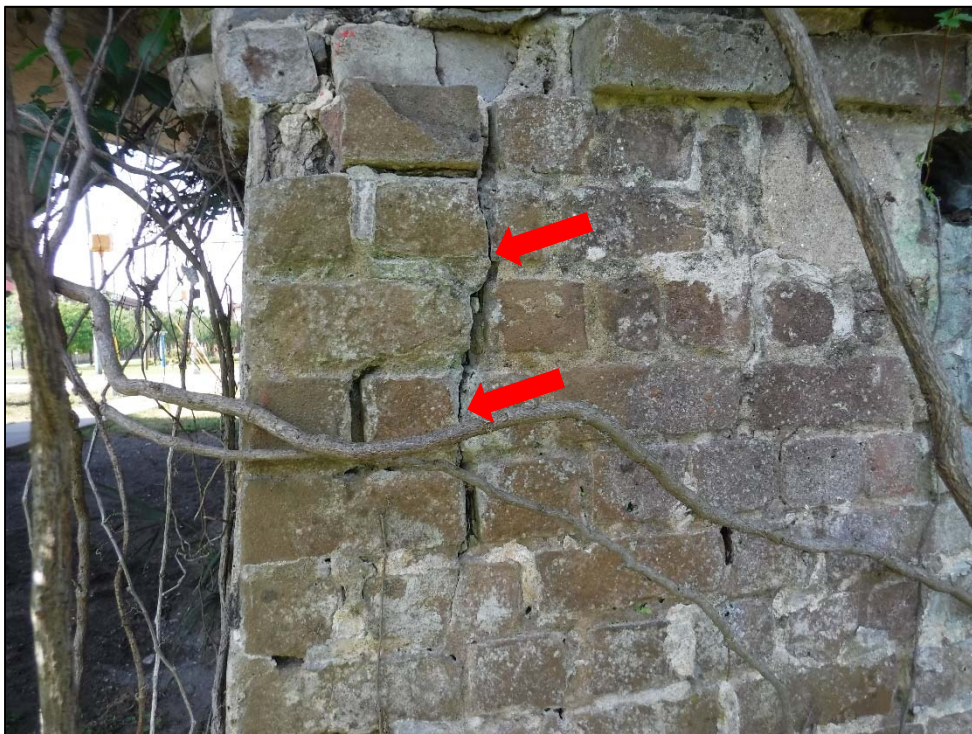
- A crack up to 1/8-in wide by 22-in long with three damaged/cracked bricks was observed at the northeast corner of Pier 1. (Photograph 28)
- A crack up to 1/8-in wide by 36-long with five damaged/cracked bricks was observed at Pier 2. (Photograph 29)

Photograph 28 – Crack with Damaged Bricks at Pier 1

4. All cracked/damaged bricks should be removed and replaced with bricks that match the existing in character, size, appearance, color, and composition.

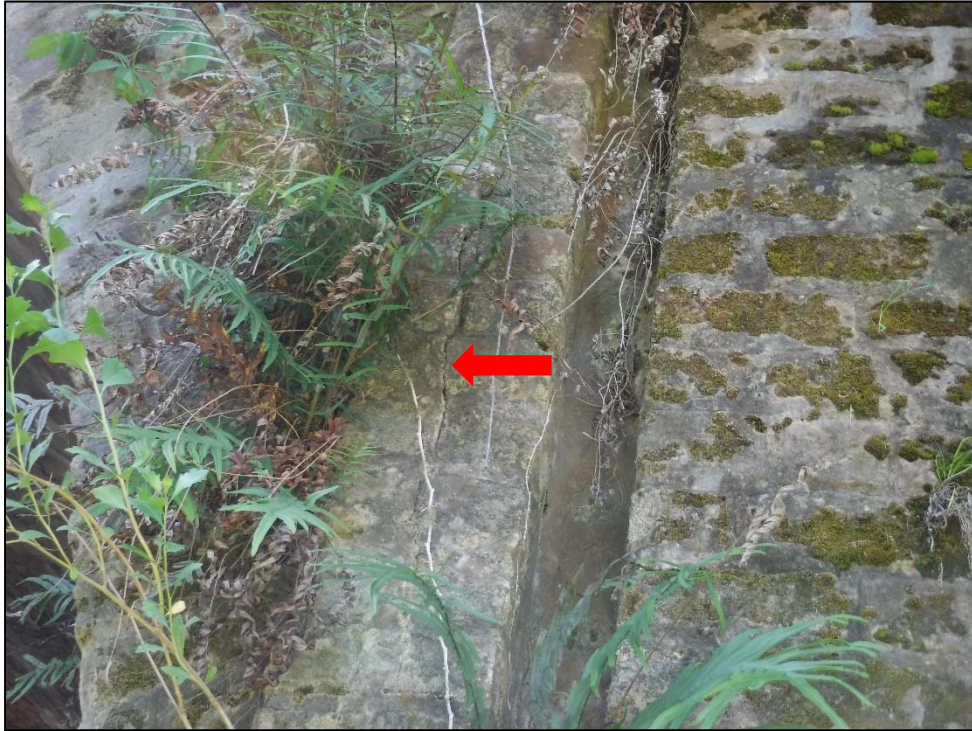
Photograph 29 – Crack with Damaged Bricks at Pier 2

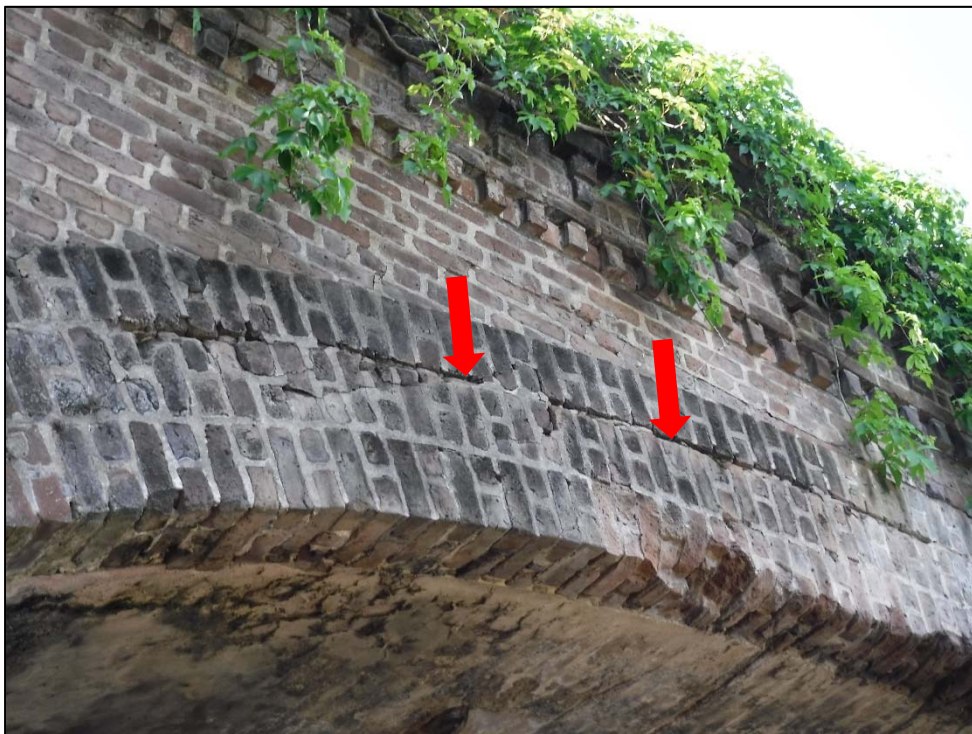
Photograph 30 – Damaged Mortar Joint at Arch Ring at Arch 3

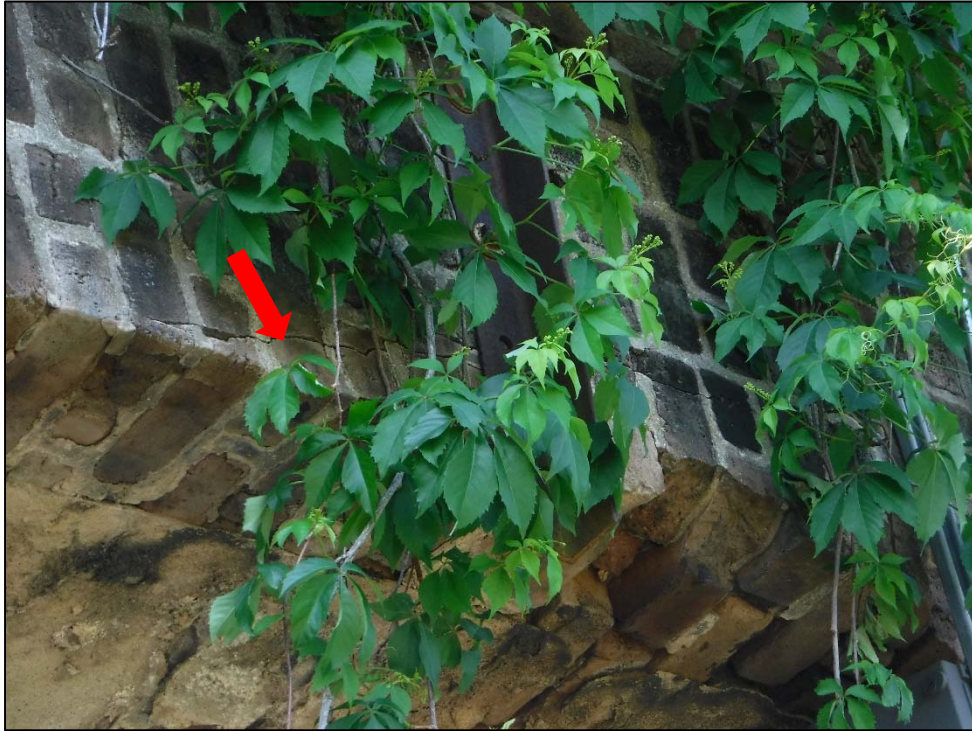
Photograph 31 – Crack with Damaged/Cracked Bricks in Arch 2

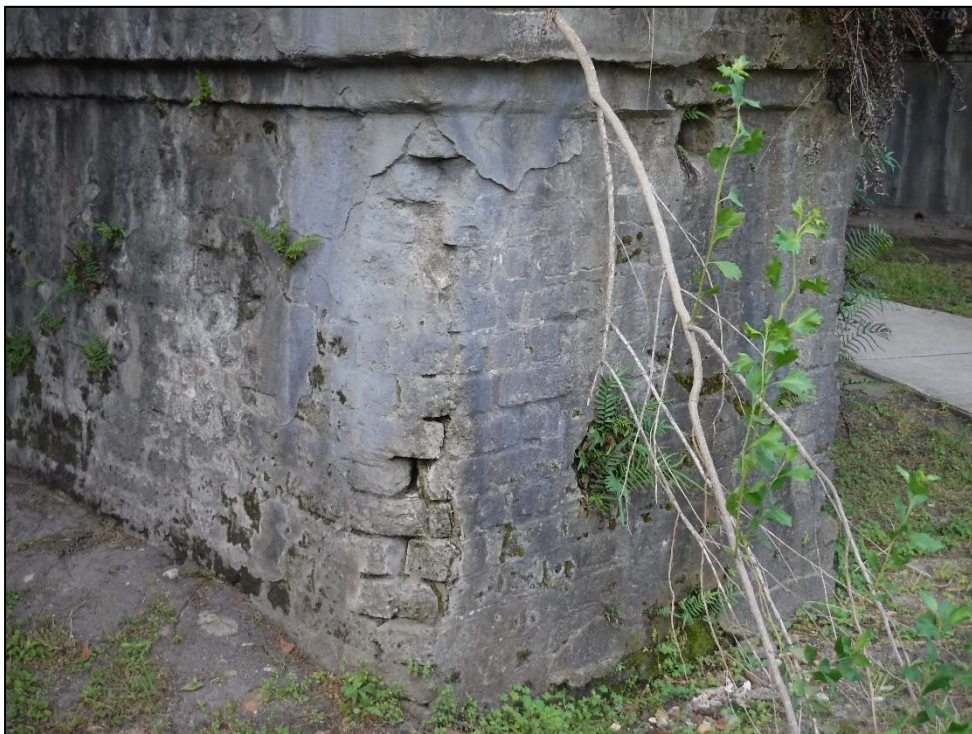
Photograph 32 – Deteriorated Previous Repair and Brick Masonry in Weep Drains

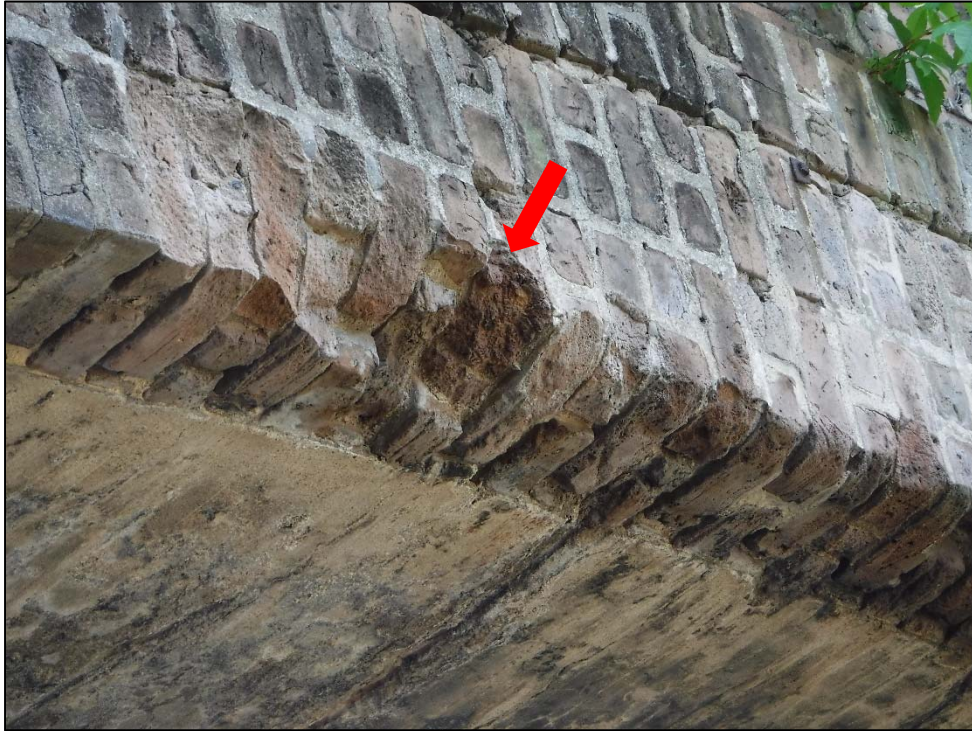
- Multiple areas of damaged or missing brick up to 2-ft long by 1-ft wide by 8-in high were observed along the outside edge of the arches. (Photograph 33)

Photograph 33 – Damaged/Missing Brick Masonry in Arches

6. All missing bricks should be replaced with bricks that match the existing in character, size, appearance, color, and composition.
  7. All graffiti should be removed. All work should be in general conformance with National Park Service Preservation Brief 38: Removing Graffiti from Historic Masonry.

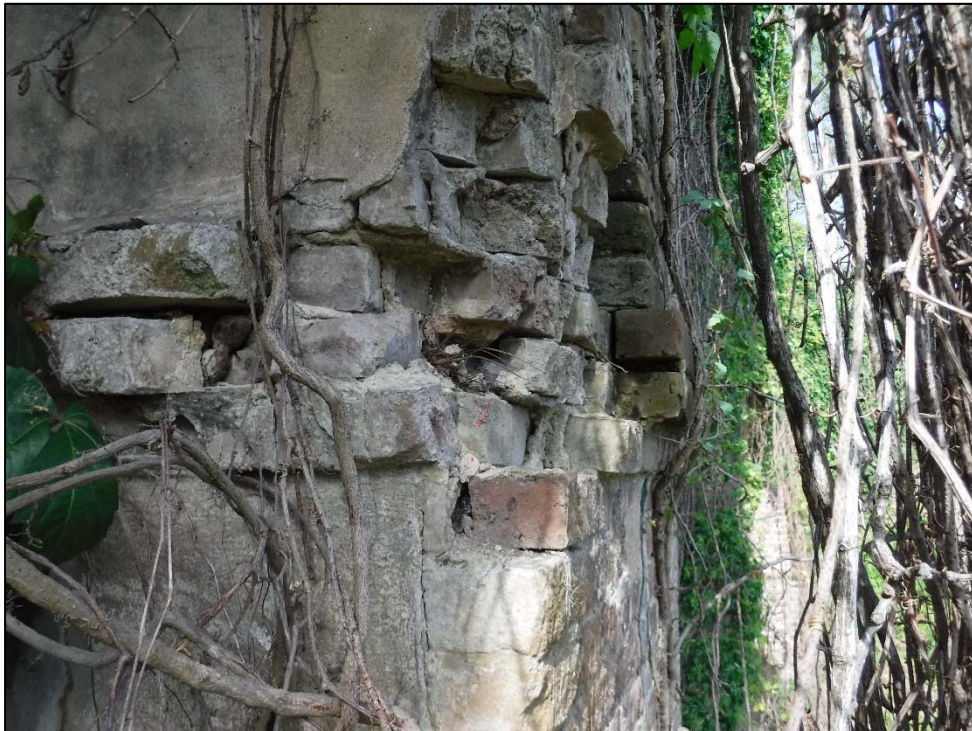
- Approximately twenty bricks were missing at the northeast corner of Pier 1. (Photograph 34)

Photograph 34 – Damaged/Missing Brick Masonry in Pier 1

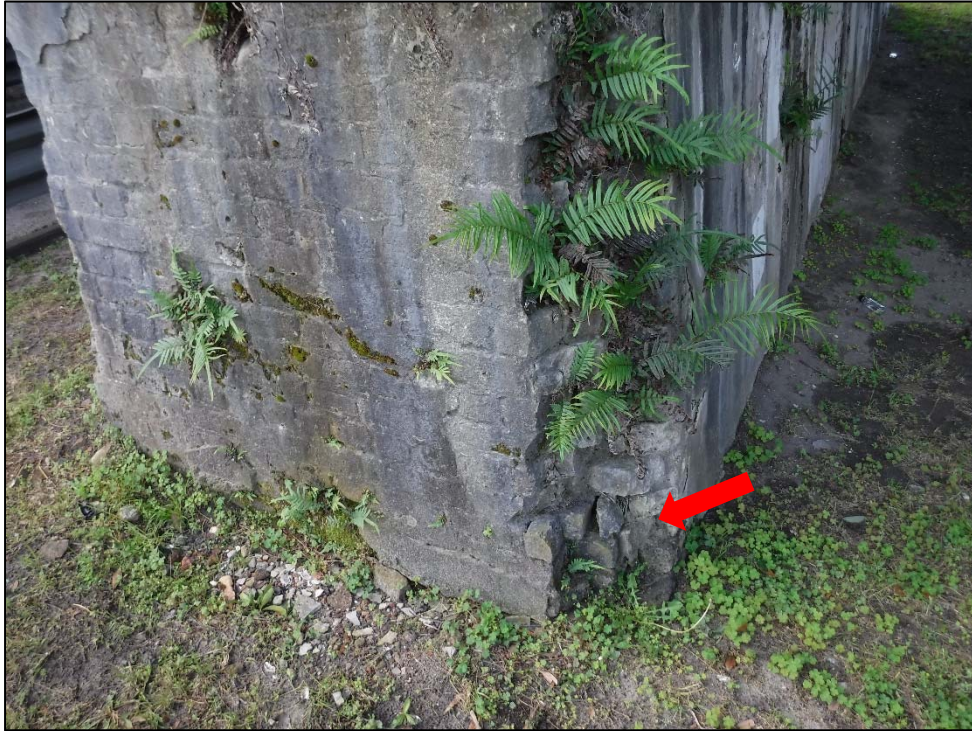
Photograph 35 – Missing Brick at Pier 2

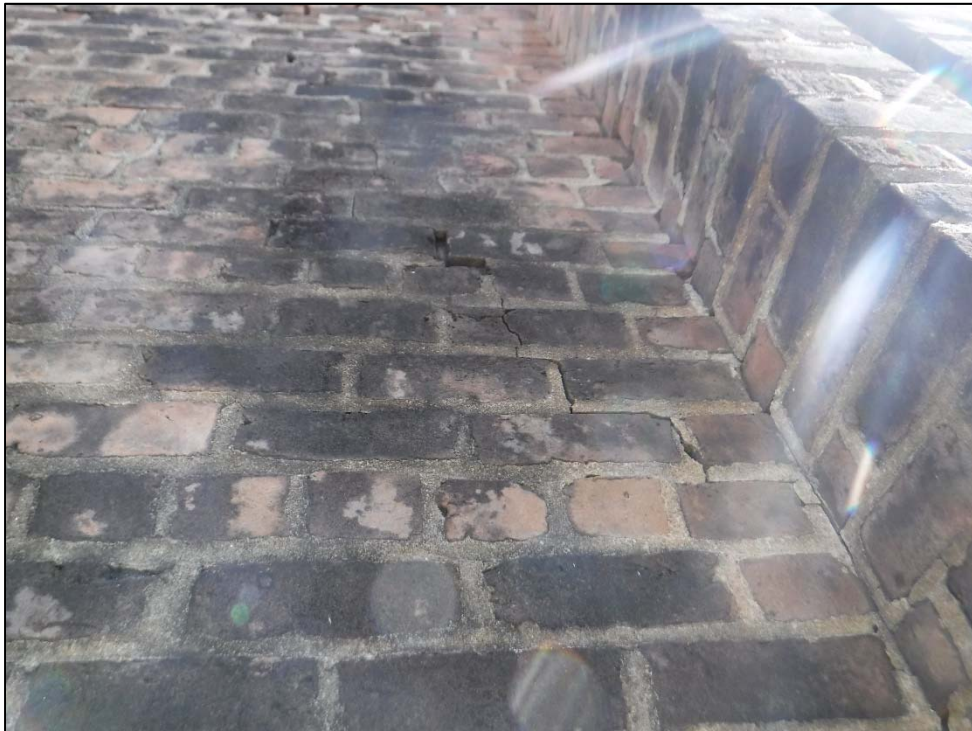
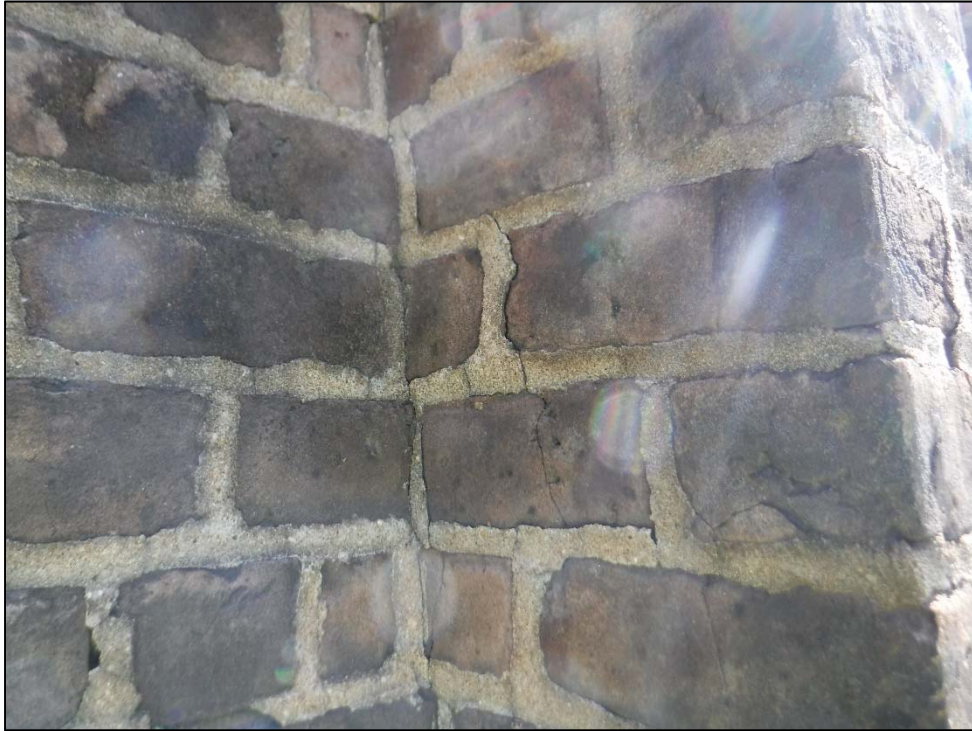
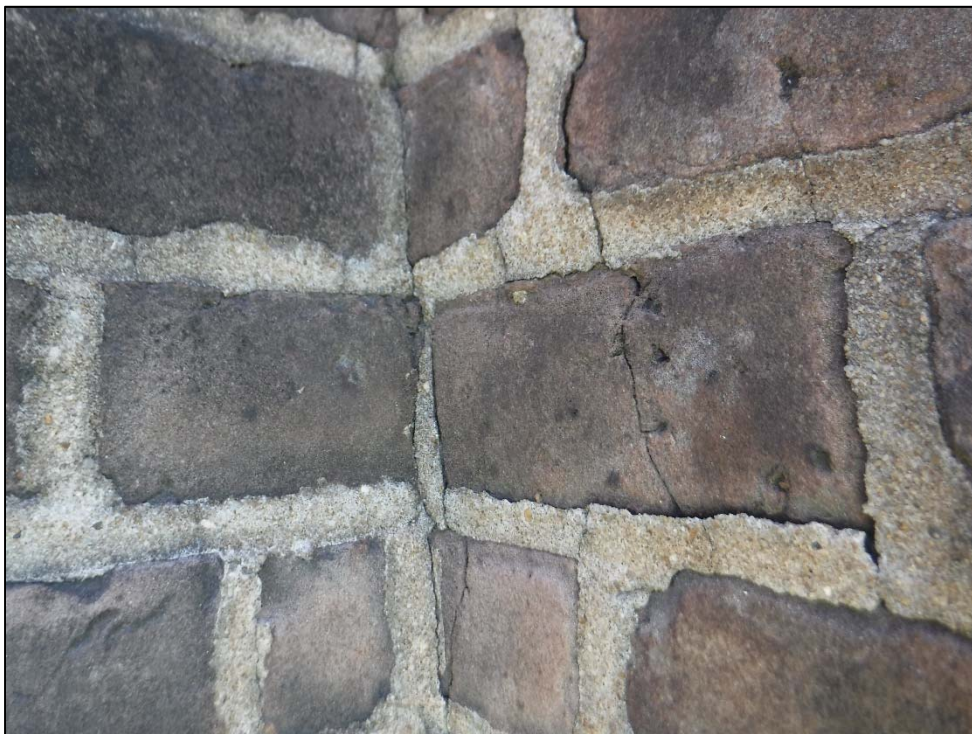
- A diagonal crack up to 1/4-in wide by 17-ft high with sixteen damaged/cracked bricks was observed in the brick masonry west of Arch 1; the crack propagates through the south face into the pier build-out. (Photographs 45 through 49)

Photograph 45 – Crack with Damaged Bricks

Photograph 46 – Crack with Damaged Bricks

Photograph 47 – Crack with Damaged Bricks

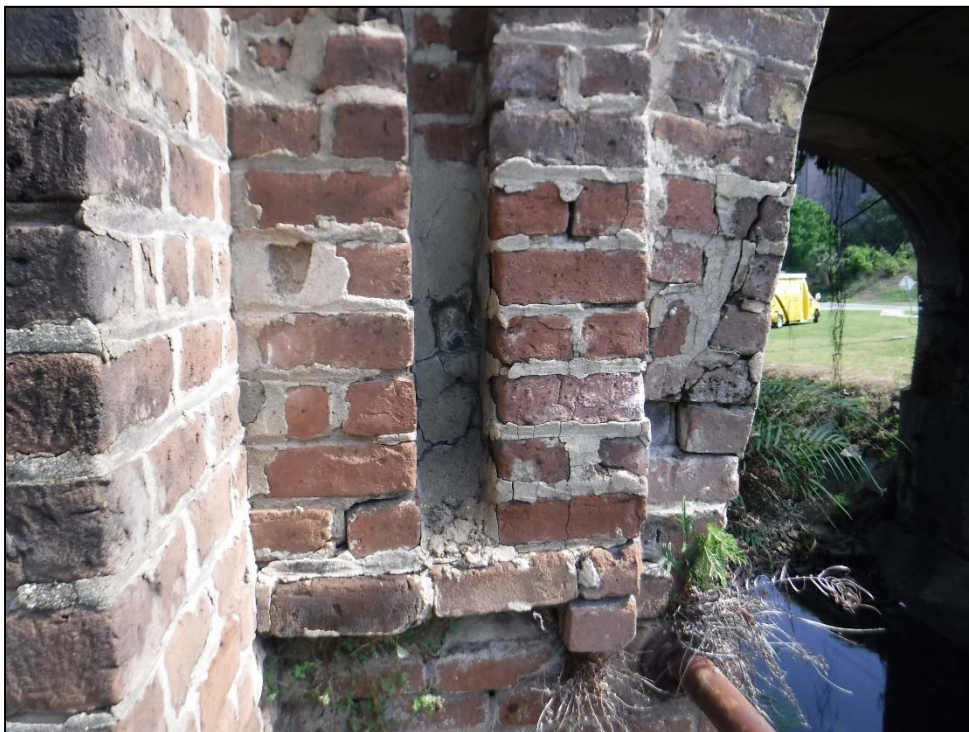
- A mortar parging was applied at the lower west portion of Arch 1 during a previous repair program. The parging has cracked up to 5/8-in. wide and spalled up to 16-in high by 4-in wide. Four missing bricks and six damaged/cracked bricks were observed at this area. (Photograph 50)

Photograph 50 – Cracked/Spalled Mortar Parging with Missing  
And Damaged Bricks at Arch 4

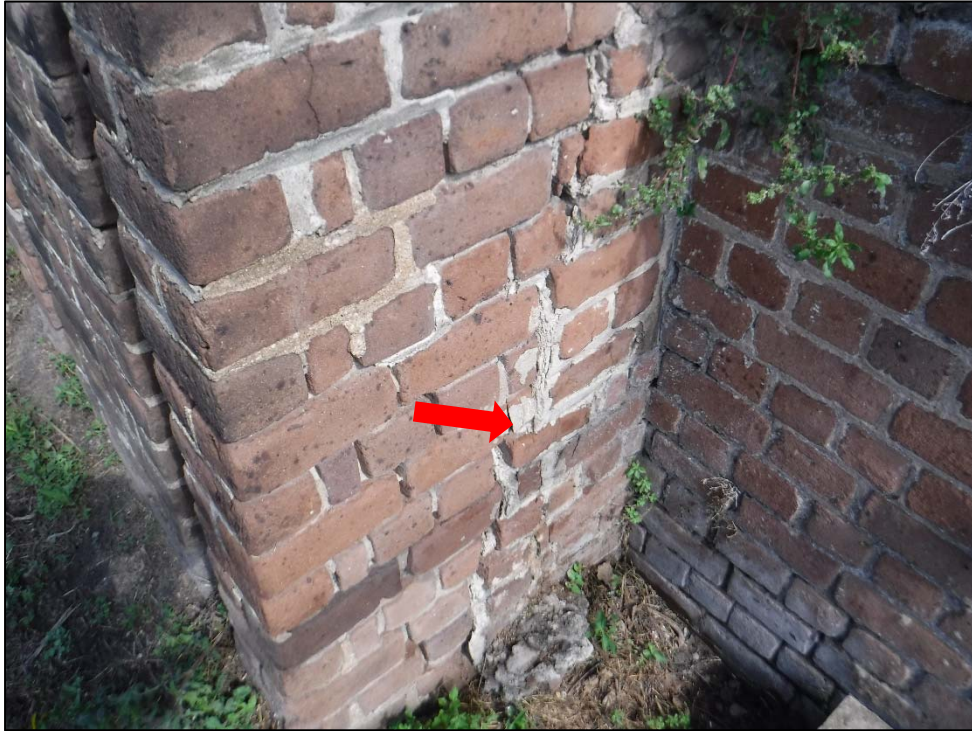
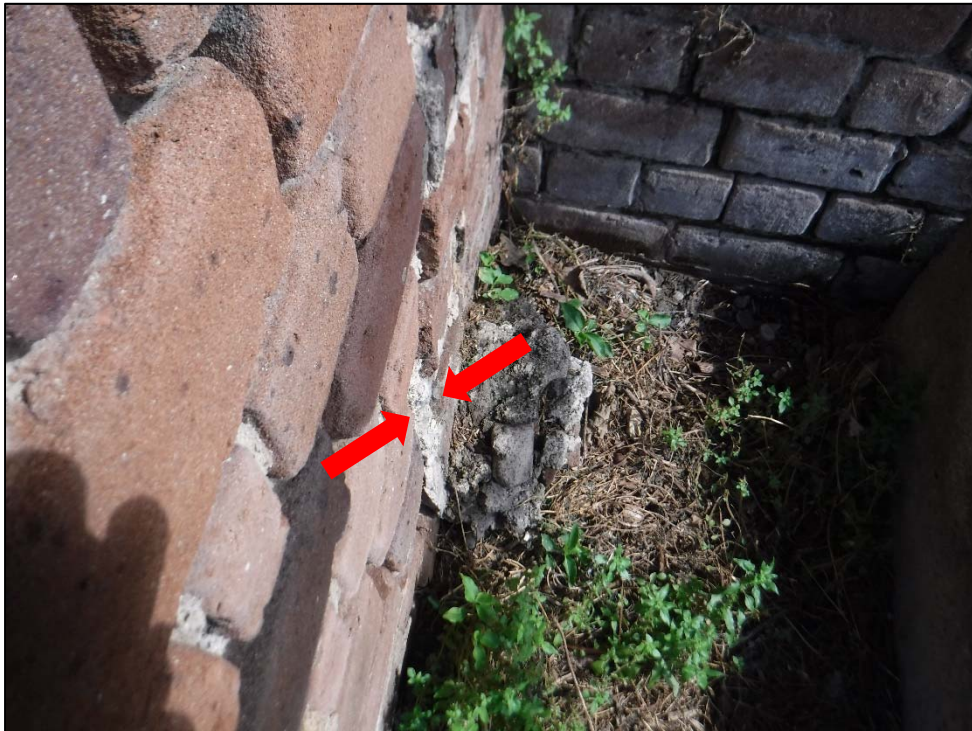
- A crack up to 1/2-in wide by 4-ft high was observed at the east face of the buildout west of Arch 1; differential displacement up to 3/4-in. was observed along the crack. (Photographs 51 and 52)

Photograph 51 – Crack with Differential Displacement

Photograph 52 – Crack with Differential Displacement

18. Displaced sections of the pier buildouts should be removed and reconstructed.
  19. All mortar installed during previous repair programs should be removed as part of the current repair program. The replacement mortar should match the existing in appearance, color, composition, and historic character.

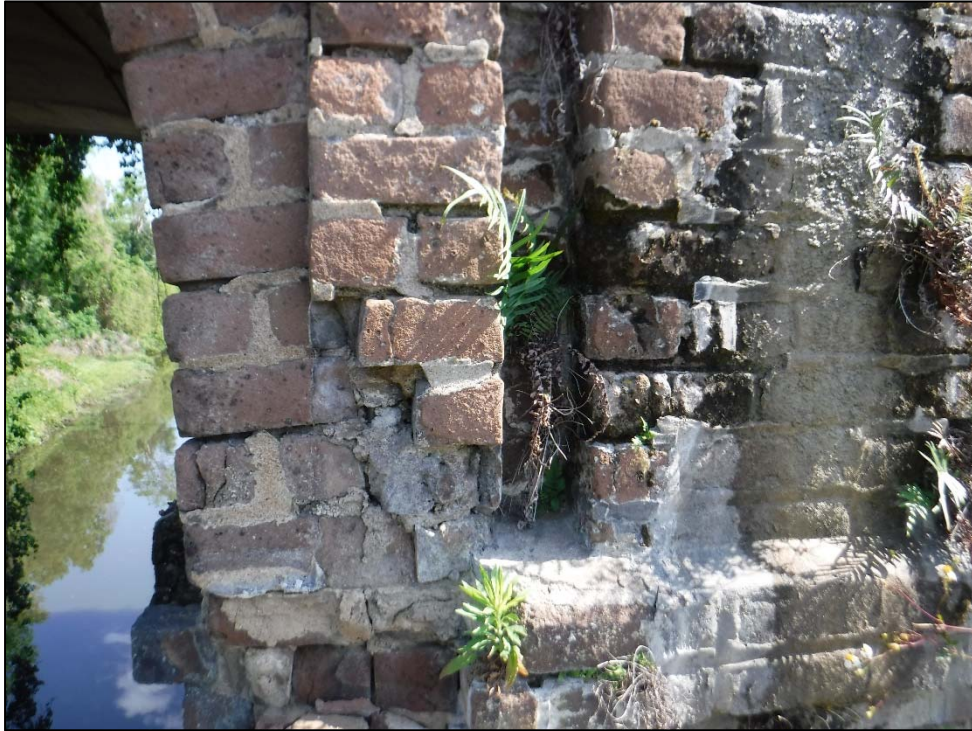
Photograph 53 – Damaged and Cracked or Missing Bricks in Arch 1

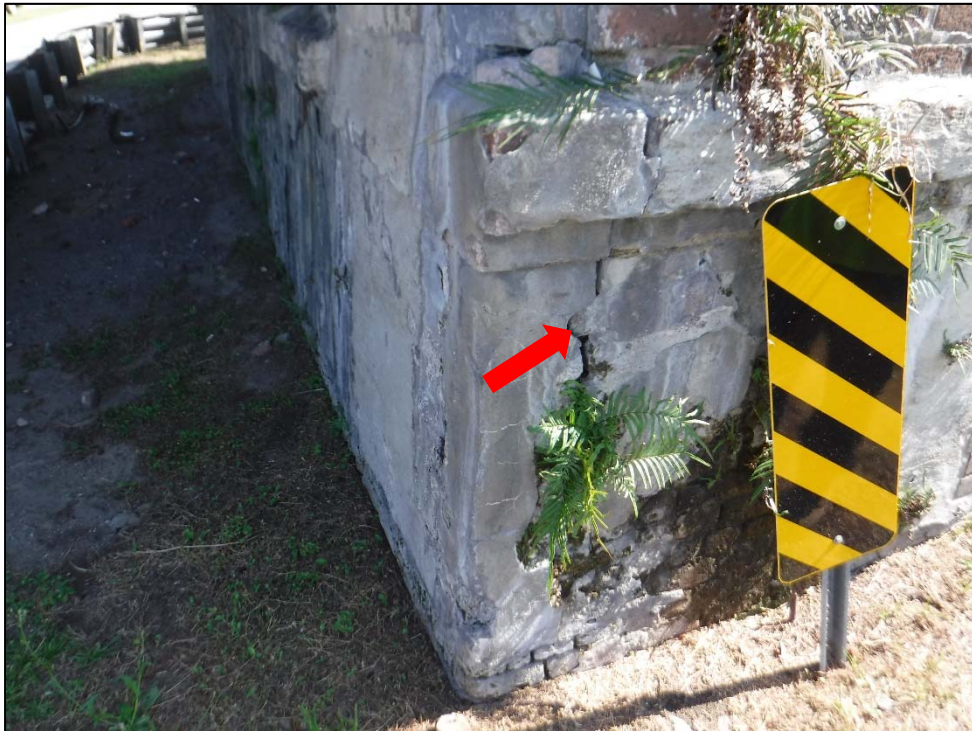
Photograph 54 – Crack with Differential Displacement at Pier 3

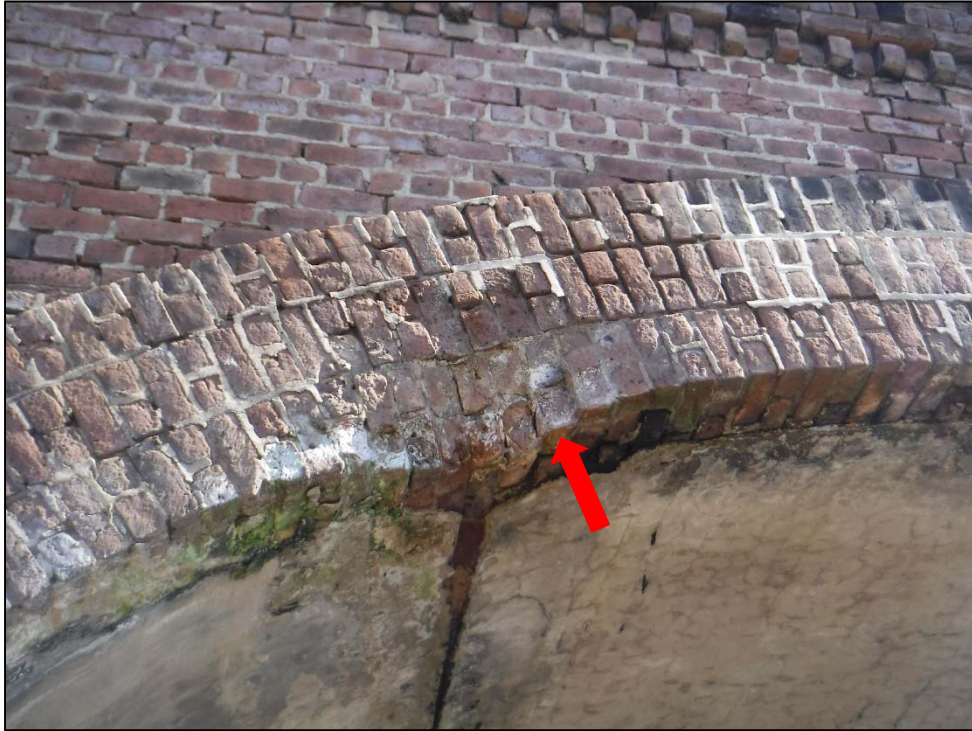
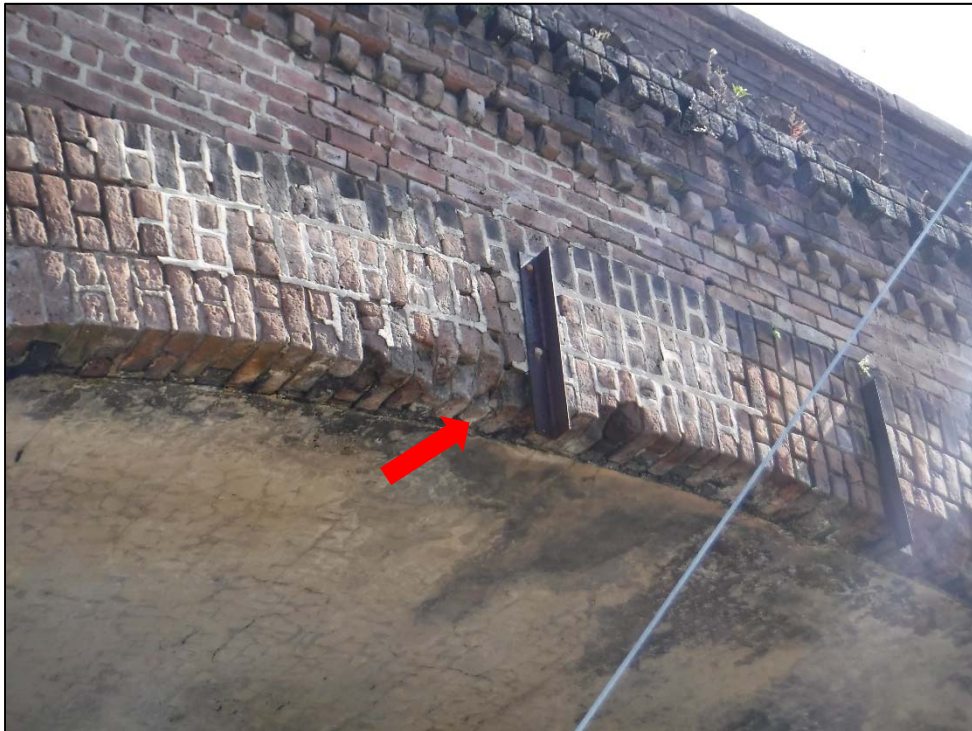
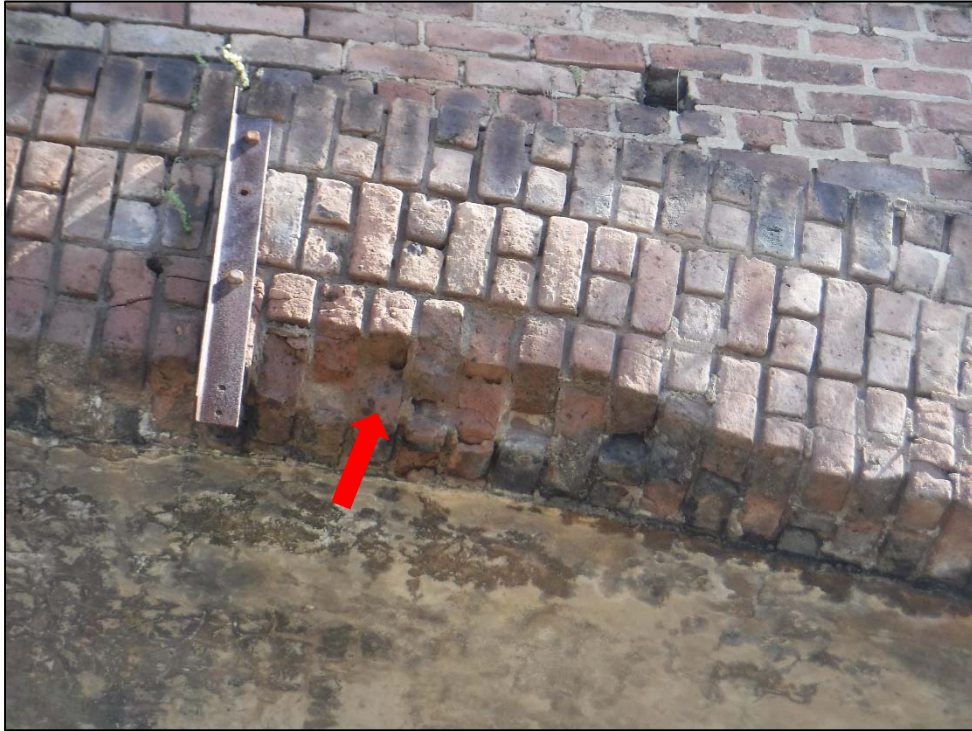
- Multiple areas of damaged or missing brick up to 3-ft long by 1-ft wide by 8-in high were observed along the outside edge of the arches. (Photographs 55, 56, and 57)

Photograph 55 – Damaged/Missing Brick in Arches

Photograph 56 – Damaged/Missing Brick in Arches

Photograph 57 – Damaged/Missing Brick in Arches

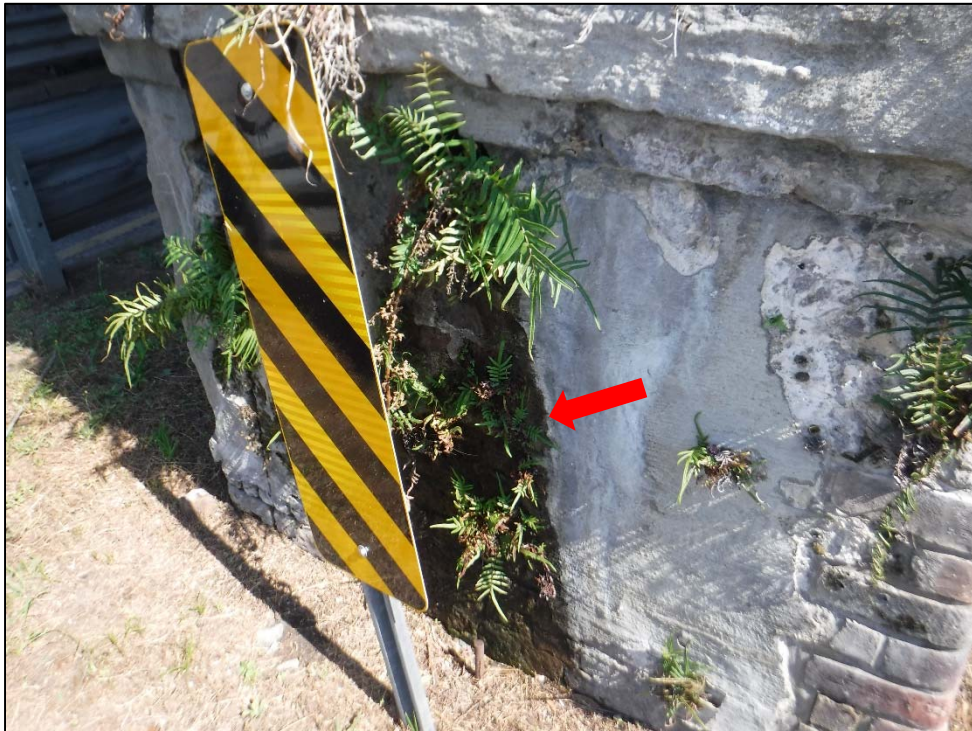
Photograph 58 – Vegetation Growth and Staining

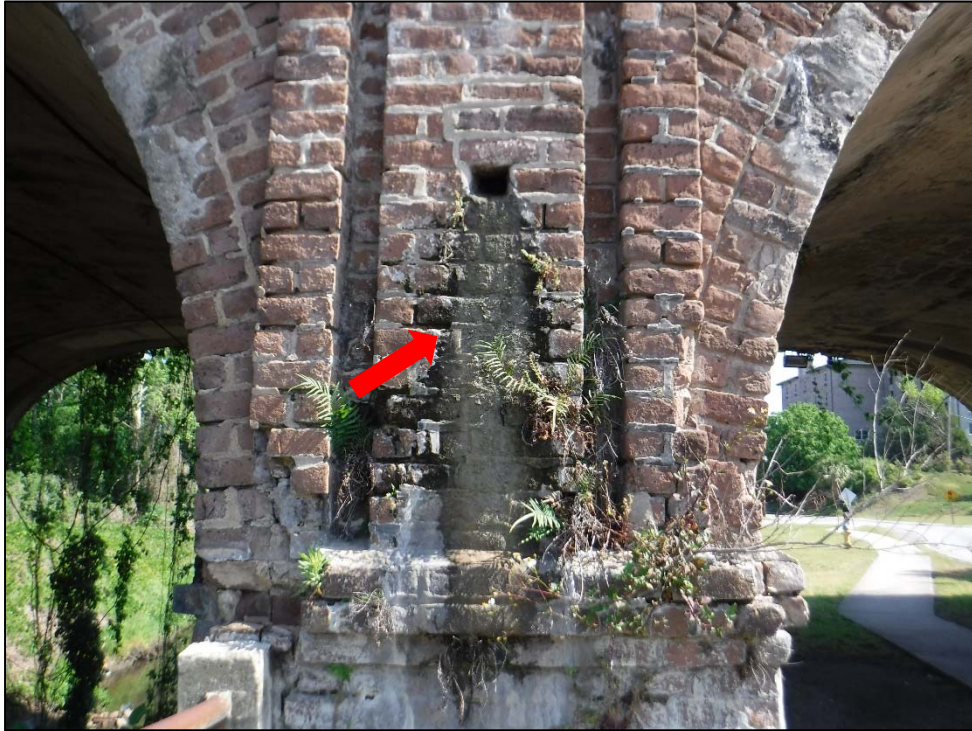
Photograph 59 – Weep Hole with Staining at Pier 1

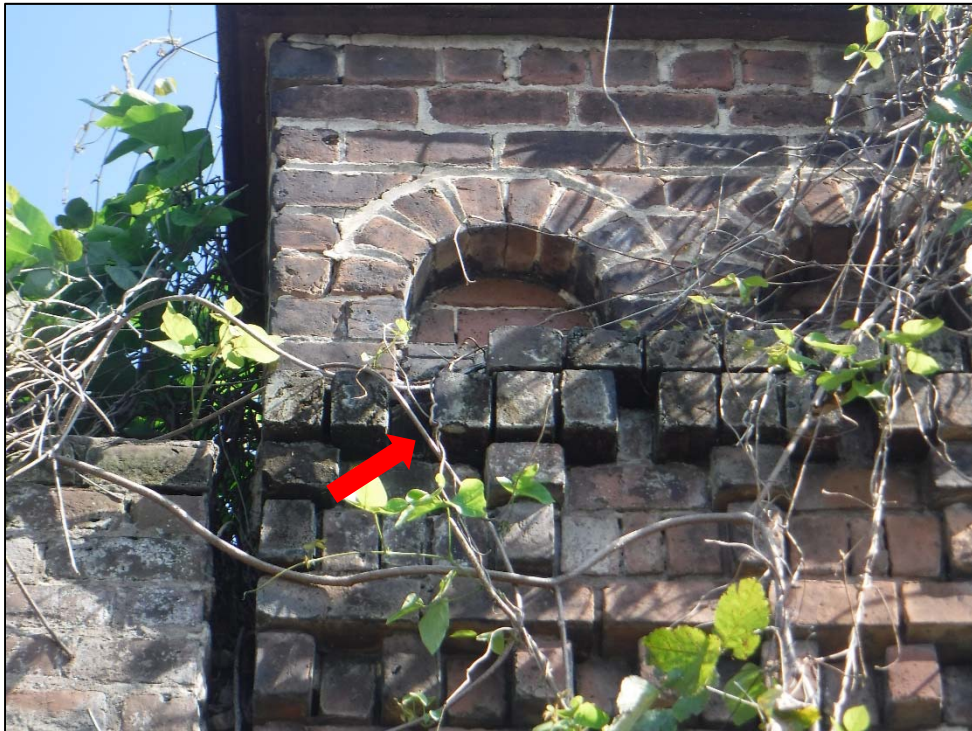
Photograph 62 – Missing Bricks in Viaduct

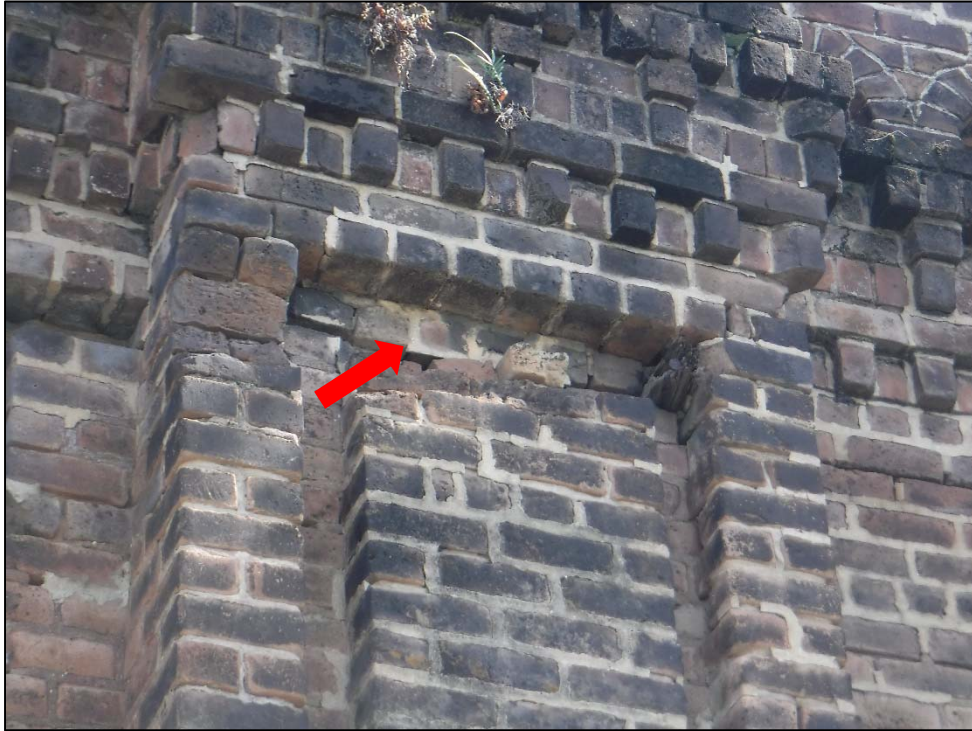
Photograph 63 – Missing Bricks

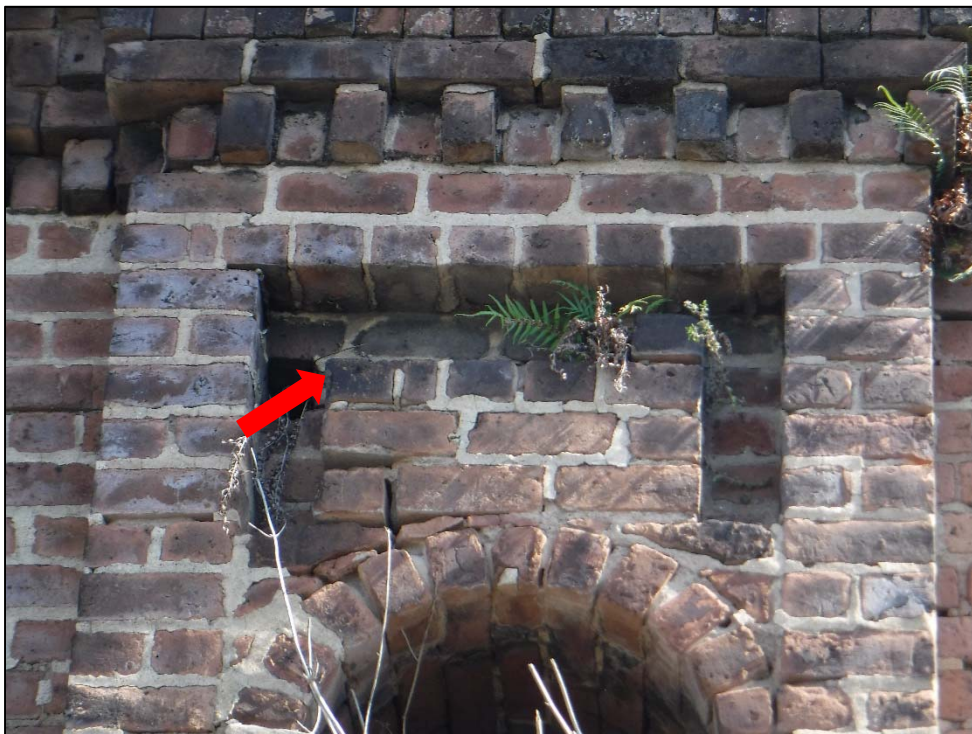
Photograph 64 – Missing Bricks at Pier 2

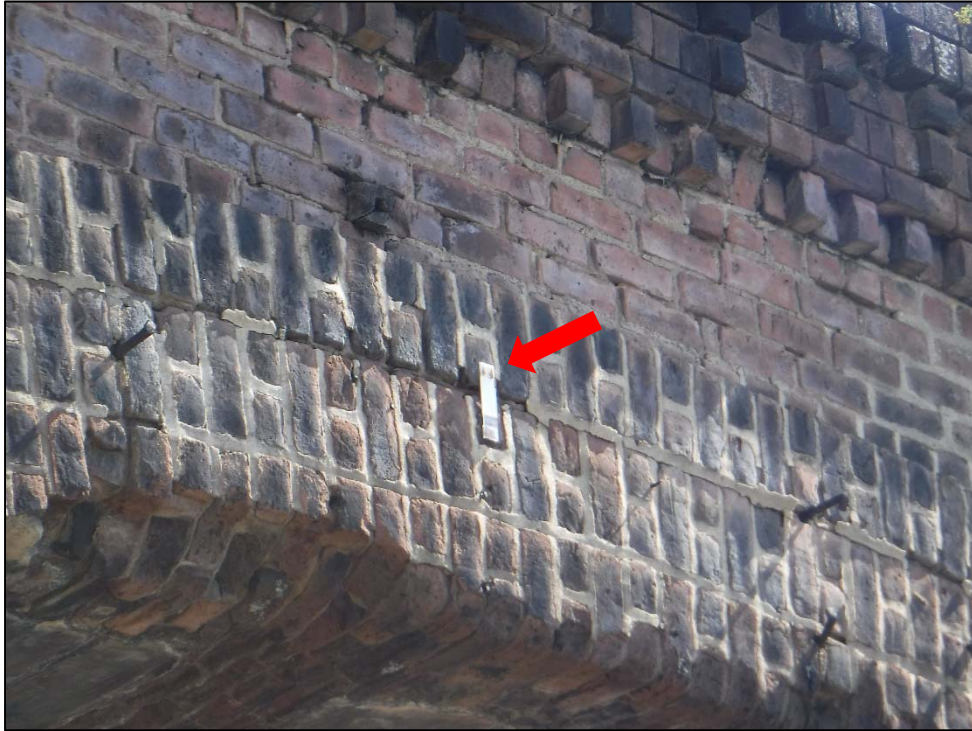
- A crack gauge was previously installed across the mortar joint between the arch ring and wall above Arch 3. (Photograph 65)
  - The guard rail at the lower west portion of Arch 1 was disconnected from its attachment to the arch. (Photograph 66)

Photograph 65 – Crack Gauge Above Arch 3

15. All existing crack gauges should be removed.
  16. All damaged guardrail should be removed and replaced.

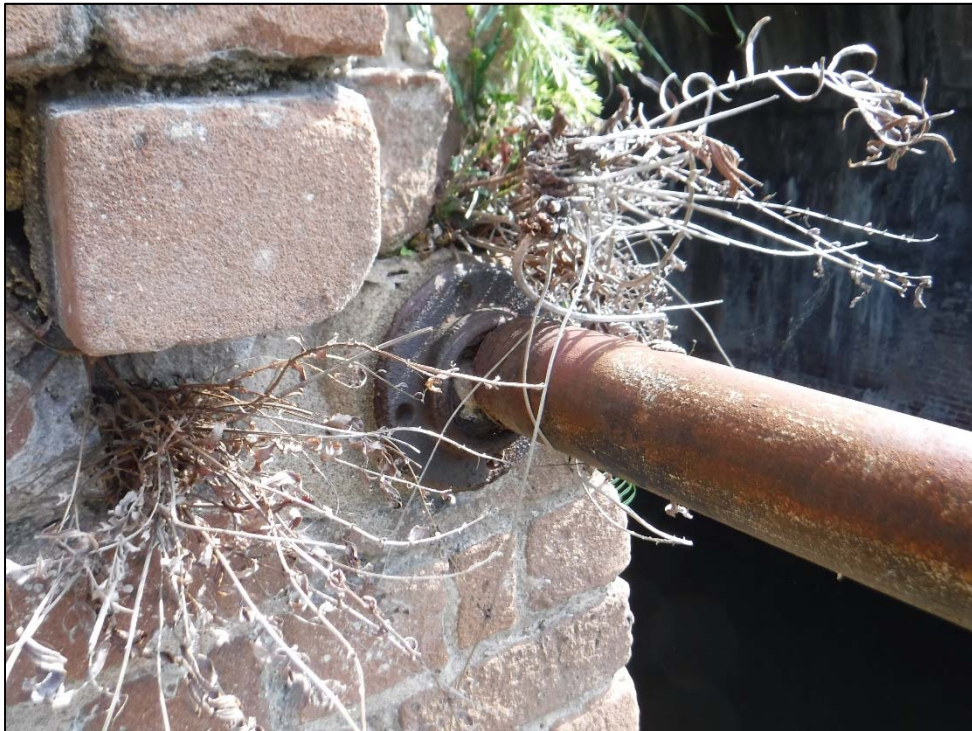
Photograph 66 – Disconnected Guardrail at Arch 1

20. The broken guardrail connection at the southwest corner of Arch 1 should be repaired.
  21. The missing guardrail vertical at the southeast corner of Arch 1 should be replaced.

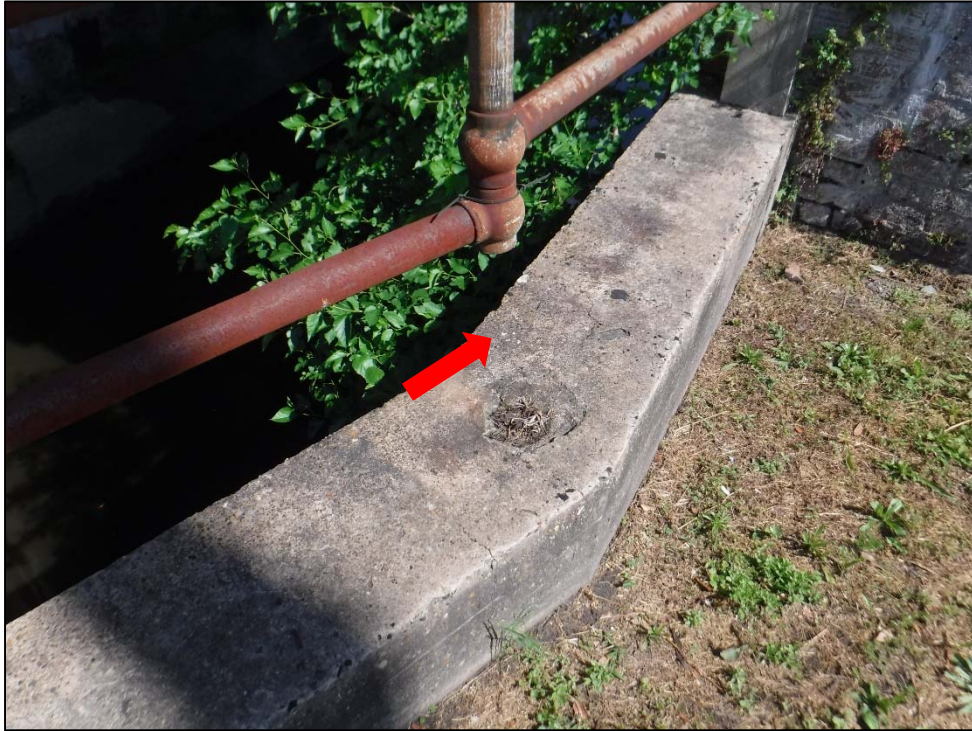
- The vertical portion of the guardrail that connects the lower horizontal member to the concrete curb was missing in front of the lower east portion of Arch 1. (Photograph 67)

Photograph 67 – Missing Portion of Guardrail at Arch 1
