# CENTRAL OF GEORGIA RAILWAY VIADUCT ASSESSMENT

Inspection Date: April 14, 2020  
Submittal Date: May 8, 2020

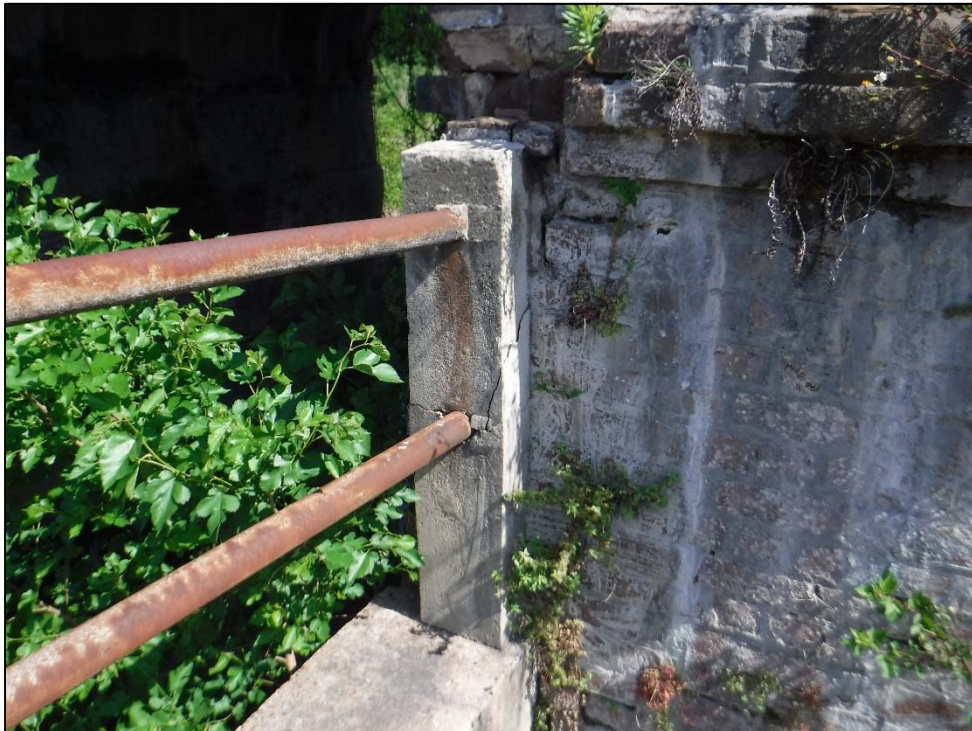
- Cracking up to 1/8-in was observed in the concrete in the vicinity of the rail connection at the southeast corner of Arch 1. (Photograph 68)

Photograph 68 – Cracking Near Rail Connection at Arch 1

22. Cracks in the concrete in the vicinity of the guard rail connections should be repaired.
  23. All broken, loose, or damaged mortar should be removed and replaced along the construction joints between the wingwalls and viaduct.

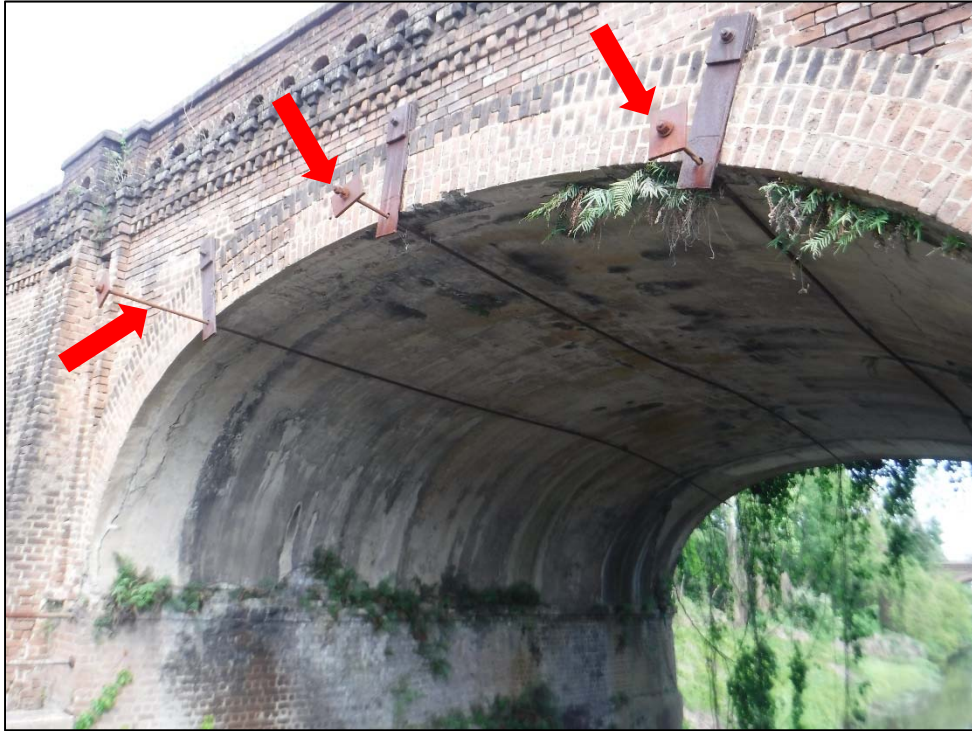
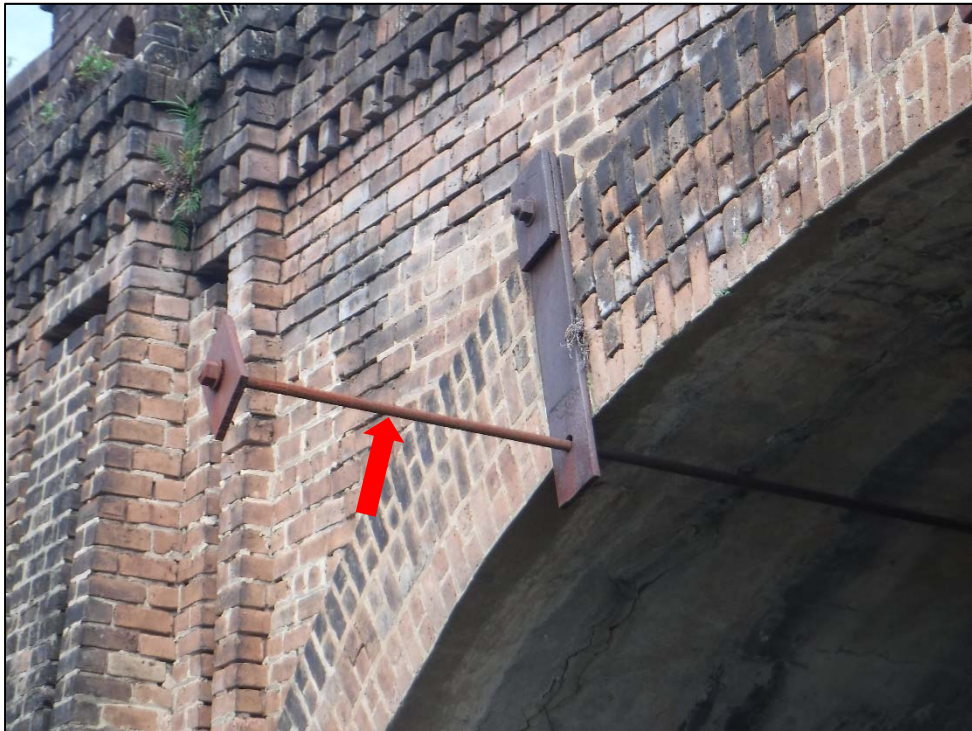
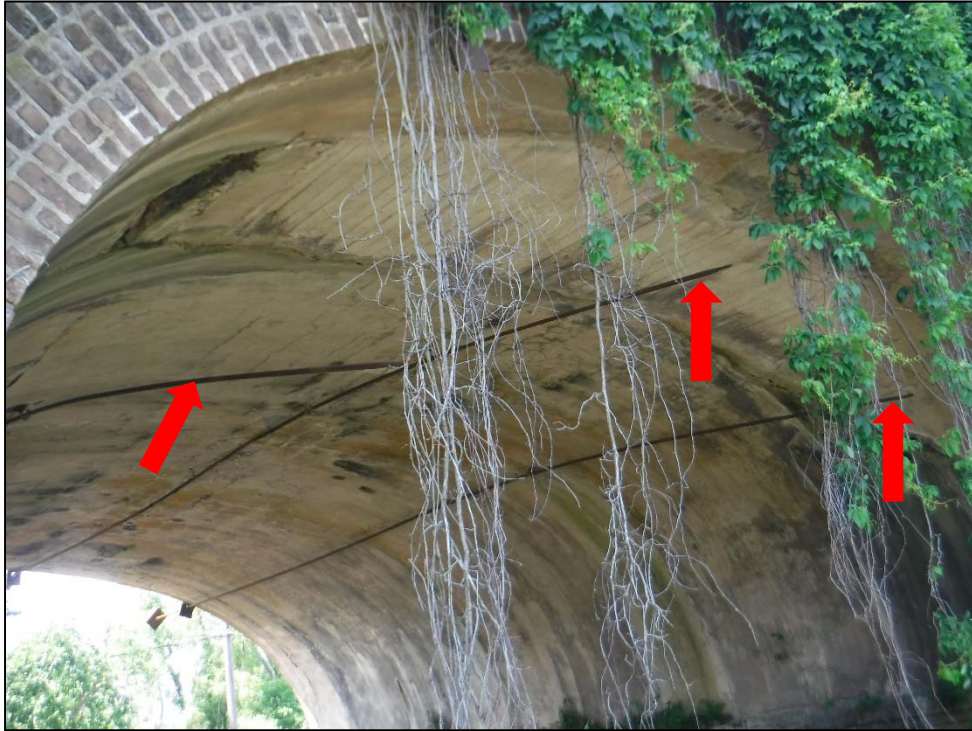
- 
- Three post-tensioning tie rods were installed across the full width of the arch; the rods appear to have been installed during a previous repair program and have subsequently failed. (Photographs 75, 76, and 77)
  - The underside of the brick masonry arch was covered with mortar; map cracking was observed throughout. (Photograph 73)

Photograph 75 – Failed Post-Tensioning Tie Rods at Arch 1

Photograph 76 – Failed Post-Tensioning Tie Rods at Arch 1

Photograph 77 – Failed Post-Tensioning Tie Rods at Arch 1

13. The mortar parging at the underside of the brick masonry at Arches 1, 2, and 3 should be removed.
  14. Stainless steel post-tensioning through-bolts should be installed across the full width of Arches 1, 2, and 3; the bolts should be installed along the curvature of the arch ring at a maximum spacing of 36-in on-center. Circular stainless steel plates should be installed at the exterior face of each bolt. Following installation of the bolts, all components of the existing failed post-tensioning tie rods at Arch 1 should be removed.

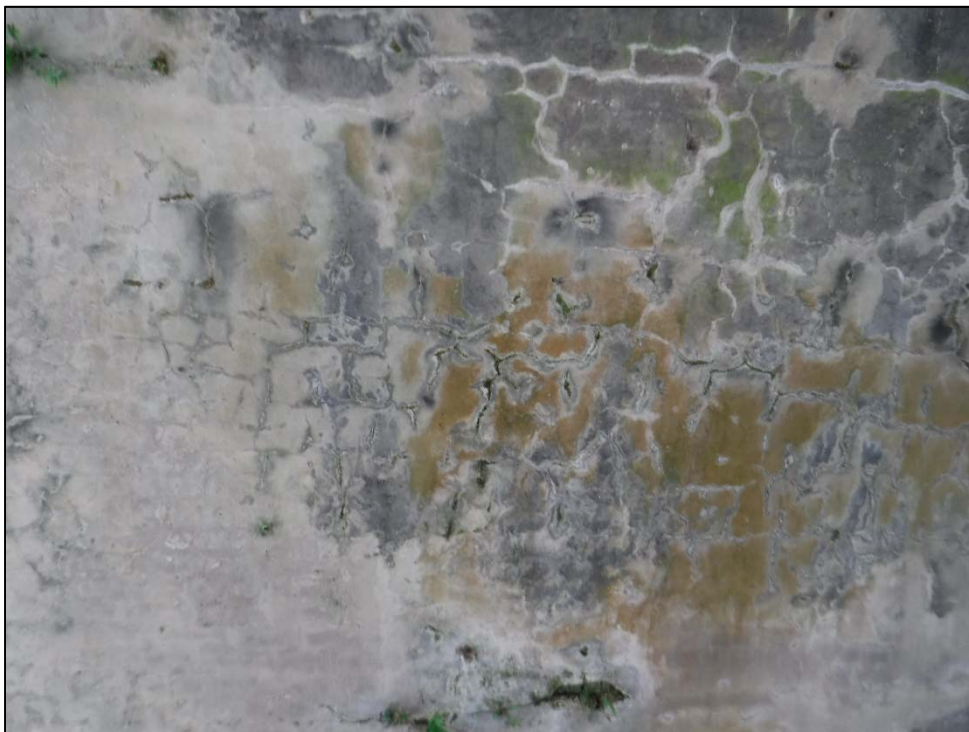
Photograph 82 – Map Cracking in Mortar in Arch 2

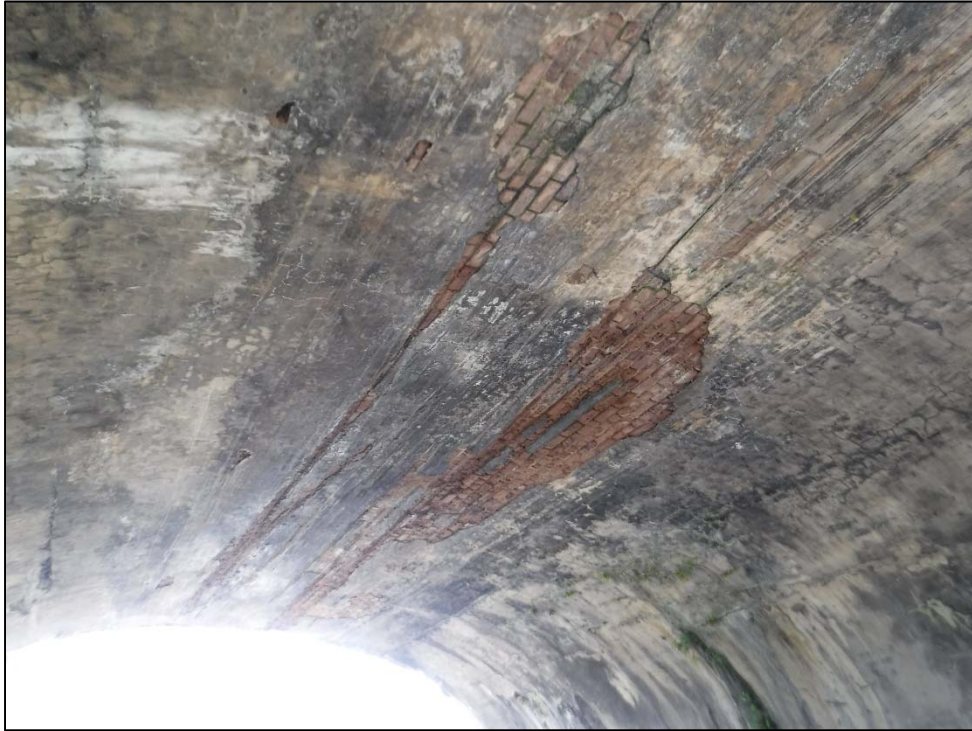
Photograph 83 – Spalled Mortar in Arch 3

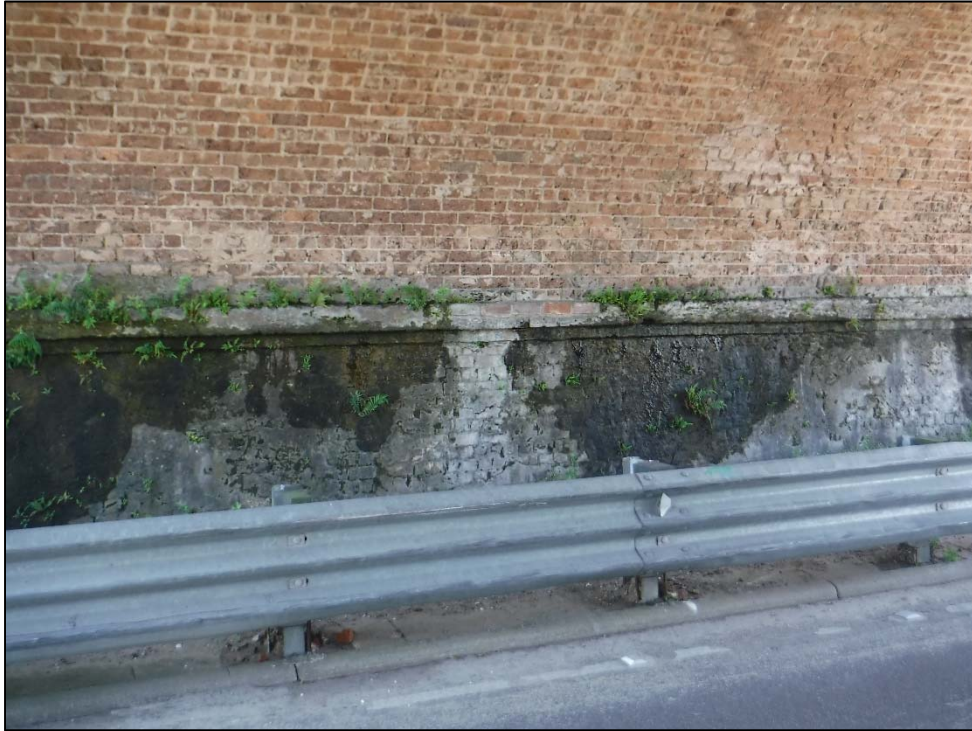
Photograph 87 – Water Staining at Arch 4

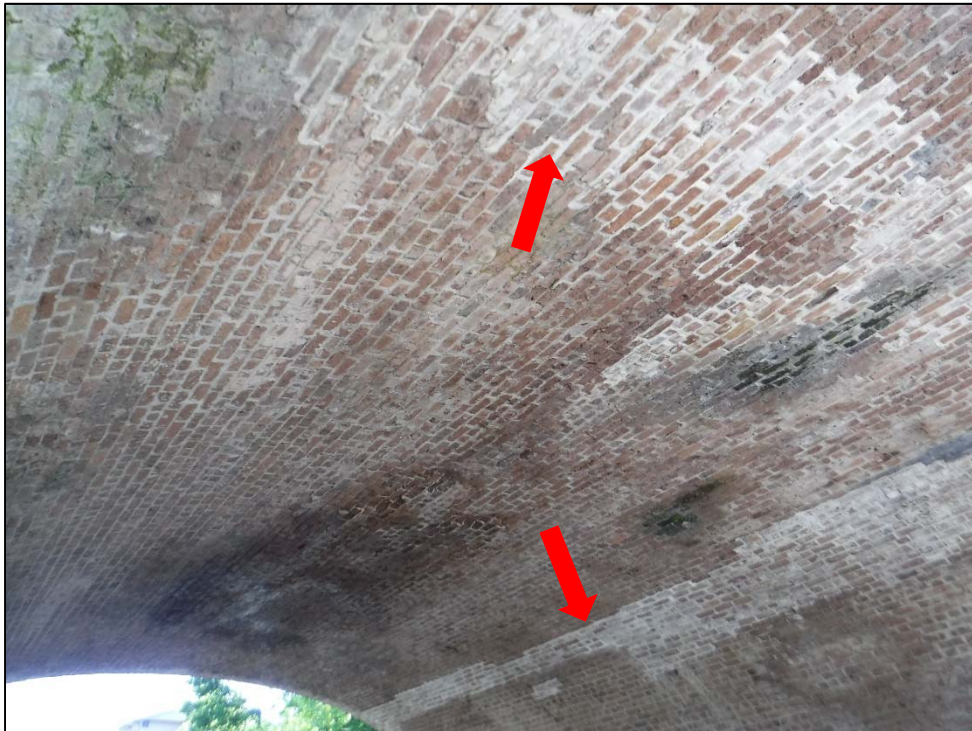
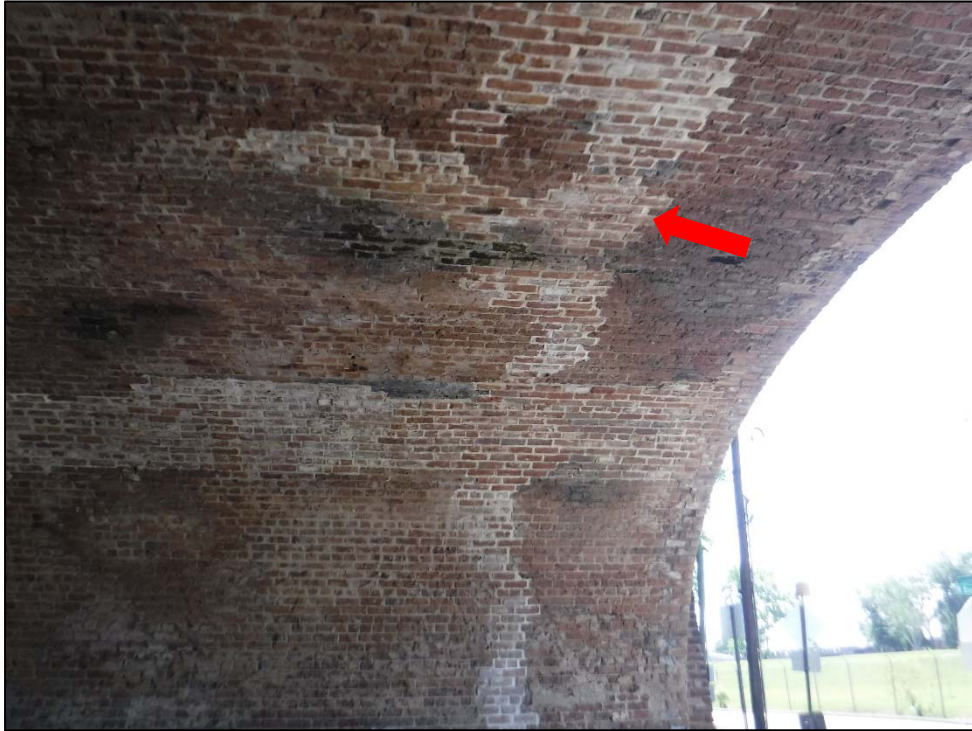
Photograph 88 – Evidence of Previous Repairs to Brick and Mortar Joints in Arch 4

Photograph 89 – Evidence of Previous Repairs to Brick and Mortar Joints in Arch 4

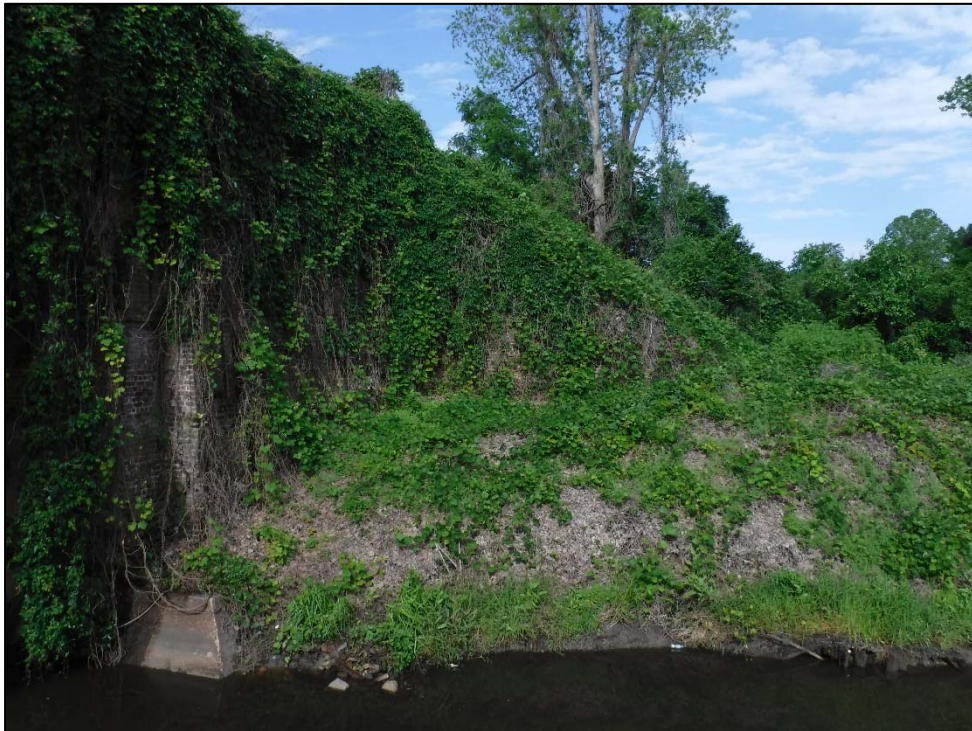
- Heavy vegetation growth was observed throughout; the condition of the brick masonry could not be determined due to the vegetation. (Photograph 90)

Photograph 90 – Vegetation Growth at Northwest Wingwall

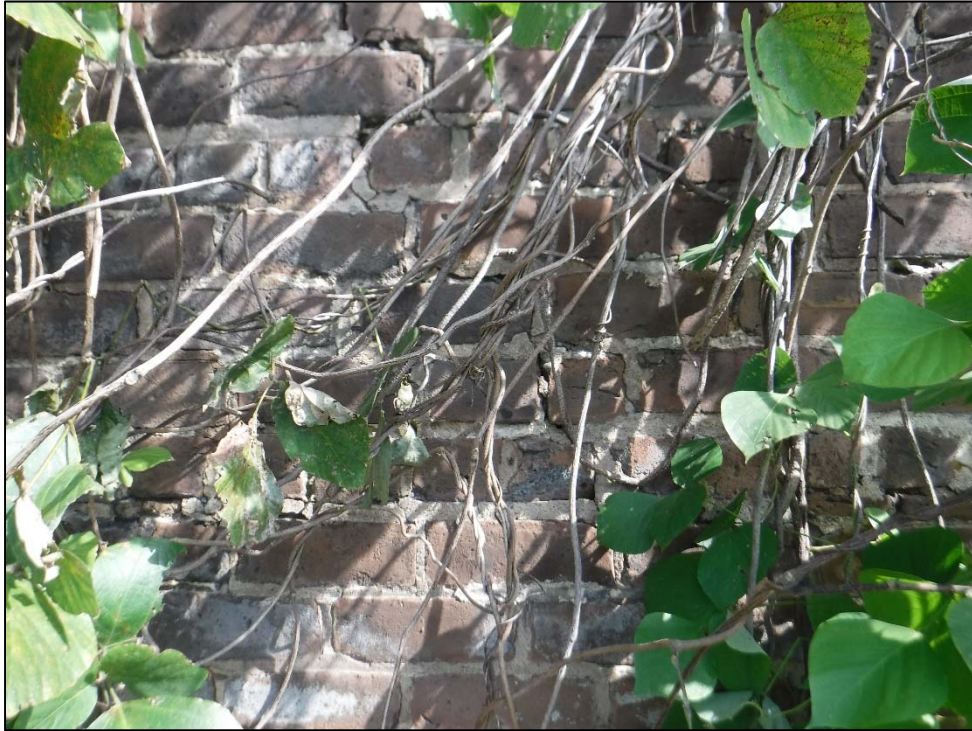
- A diagonal crack up to 1/4-in wide by at least 166-in high was observed in the brick masonry below the transition from the third to fourth step; the extent of the crack and potentially damaged brick were obstructed by vegetation growth. The crack appears to be indicative of settlement. (Photograph 91)

Photograph 91 – Diagonal Crack Obstructed by Vegetation Growth  
At Southwest Wingwall

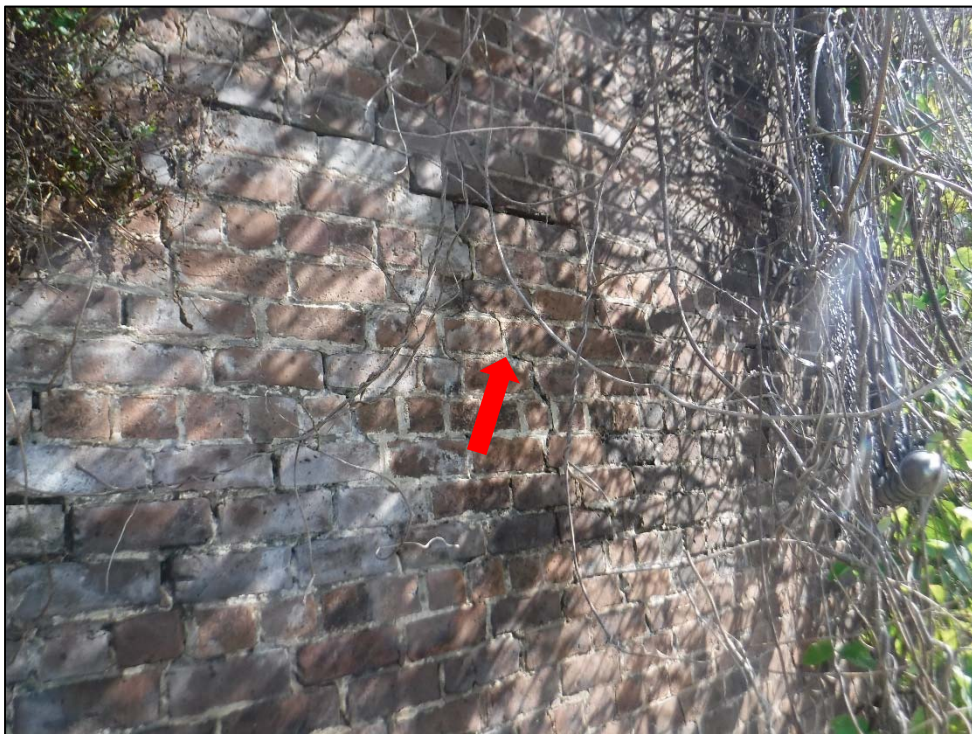
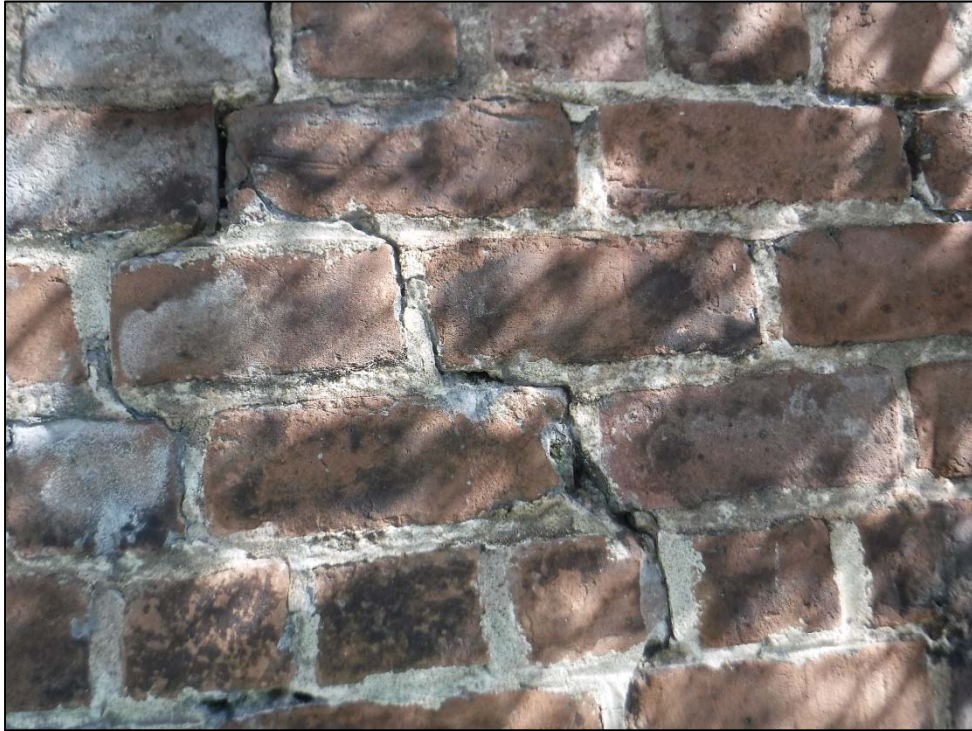
- A diagonal crack up to 1/4-in wide by 146-in high with one damaged/cracked brick was observed in the brick masonry below the transition from the second to third step. The crack appears to be indicative of settlement. (Photographs 92 and 93)

Photograph 92 – Diagonal Crack with Damaged/Crack Brick in Southwest Wingwall

Photograph 93 – Diagonal Crack with Damaged Brick in Southwest Wingwall

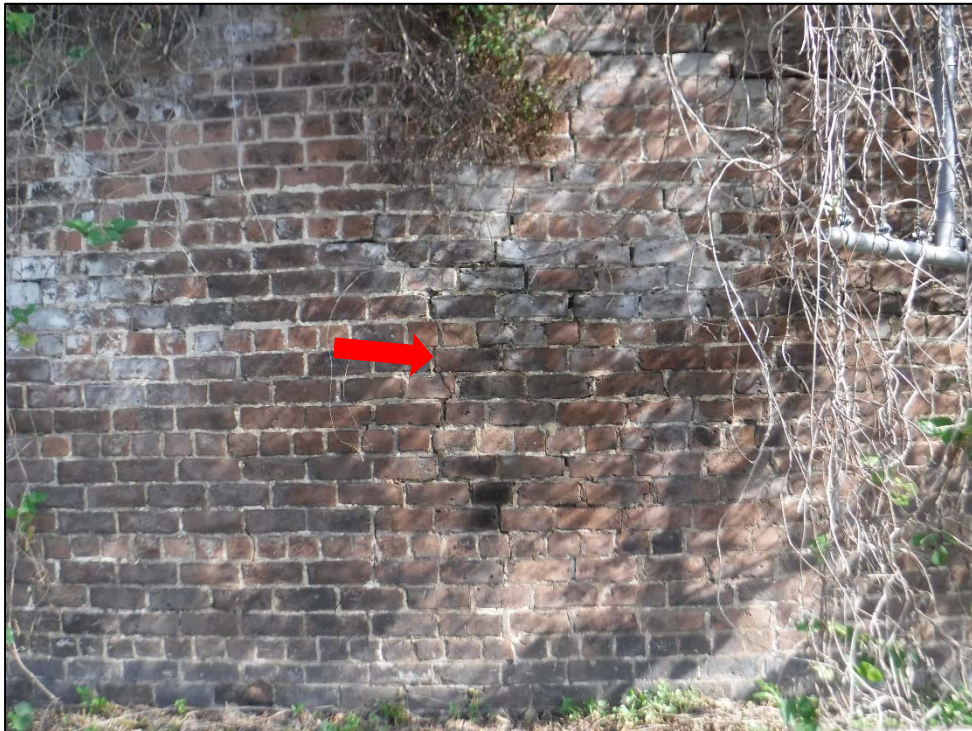
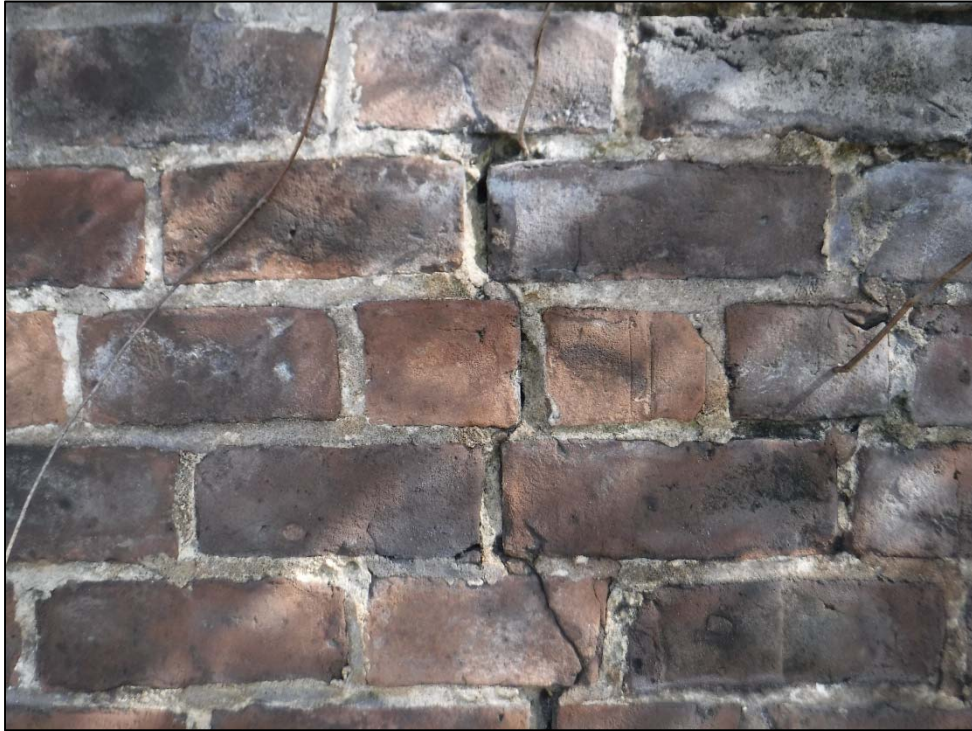
- A vertical crack up to 1/8-in wide by 99-in high with one damaged/cracked brick was observed in the brick masonry below the transition from the second to third step. The crack appears to be indicative of settlement. (Photographs 94 and 95)

Photograph 94 – Vertical Crack with Damaged Brick in Southwest Wingwall

Photograph 95 – Vertical Crack with Damaged Brick in Southwest Wingwall

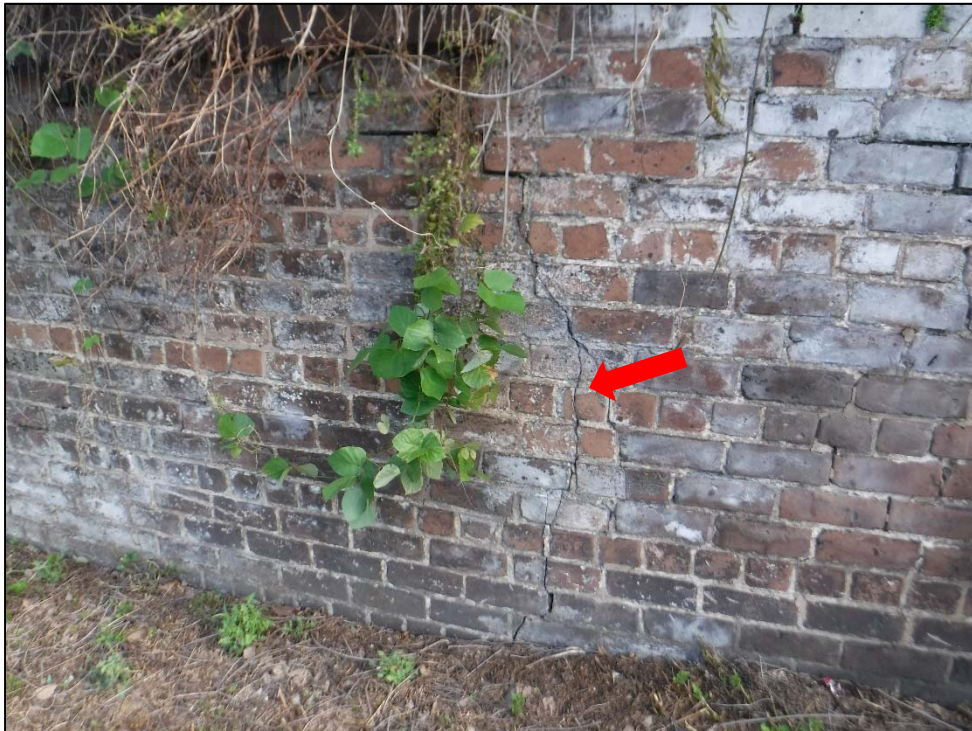
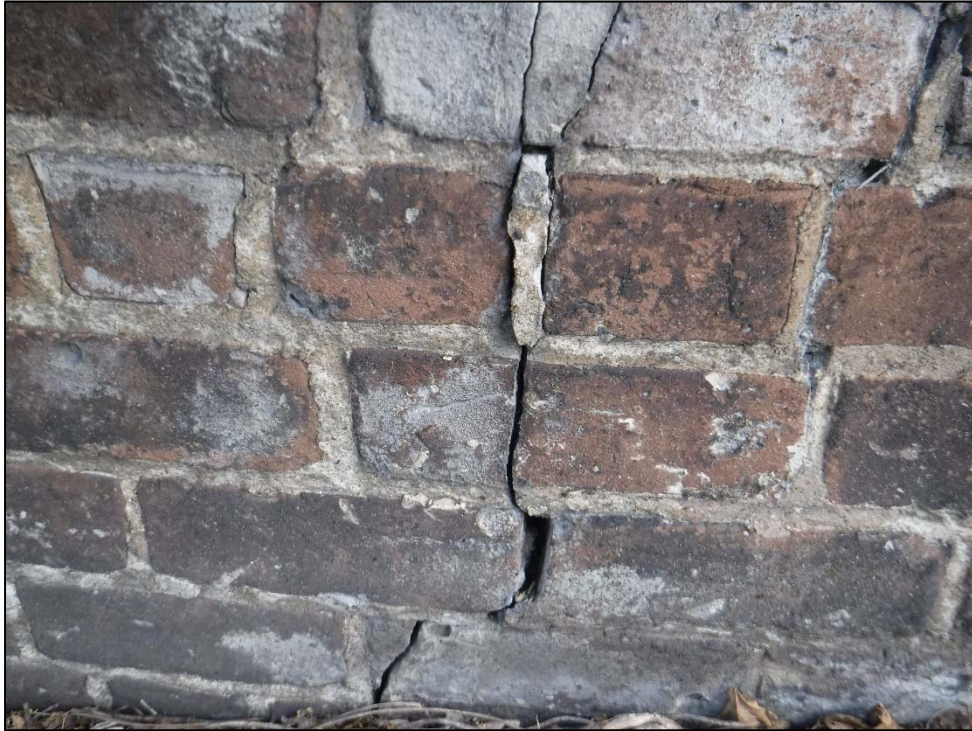
- A vertical crack up to 3/16-in wide by 72-in high with eight damaged/cracked bricks was observed in the brick masonry below the transition from the first to second step. The crack appears to be indicative of settlement. (Photographs 96 and 97)

Photograph 96 – Vertical Crack with Damaged Brick in Southwest Wingwall

Photograph 97 – Vertical Crack with Damaged Brick in Southwest Wingwall

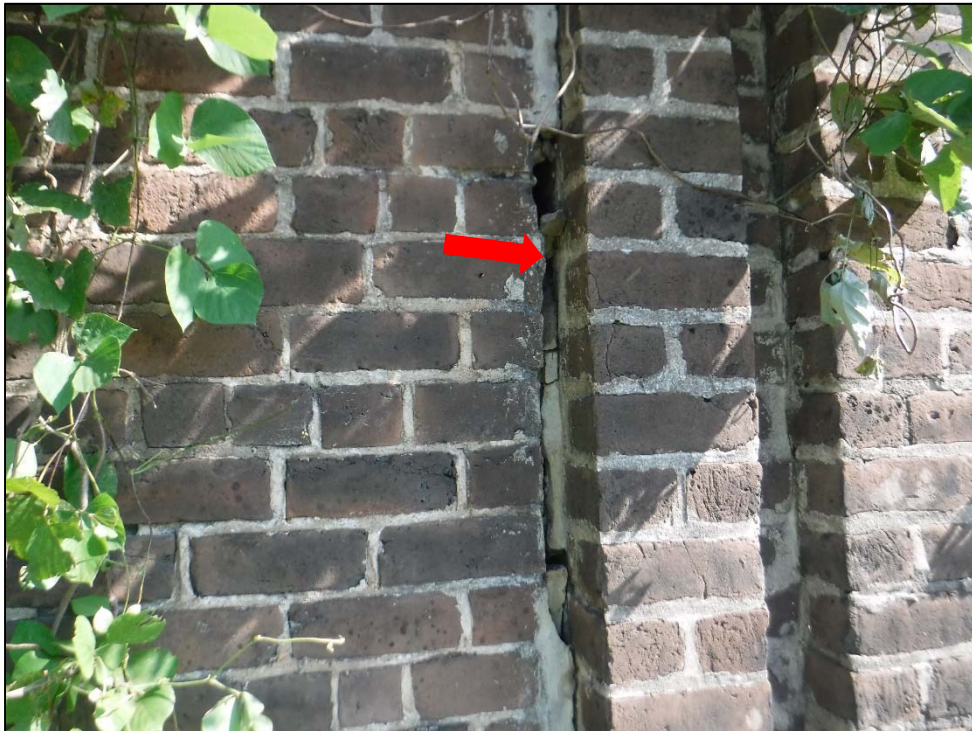
Photograph 98 – Mortar Loss Along Construction Joint in Southwest Wingwall

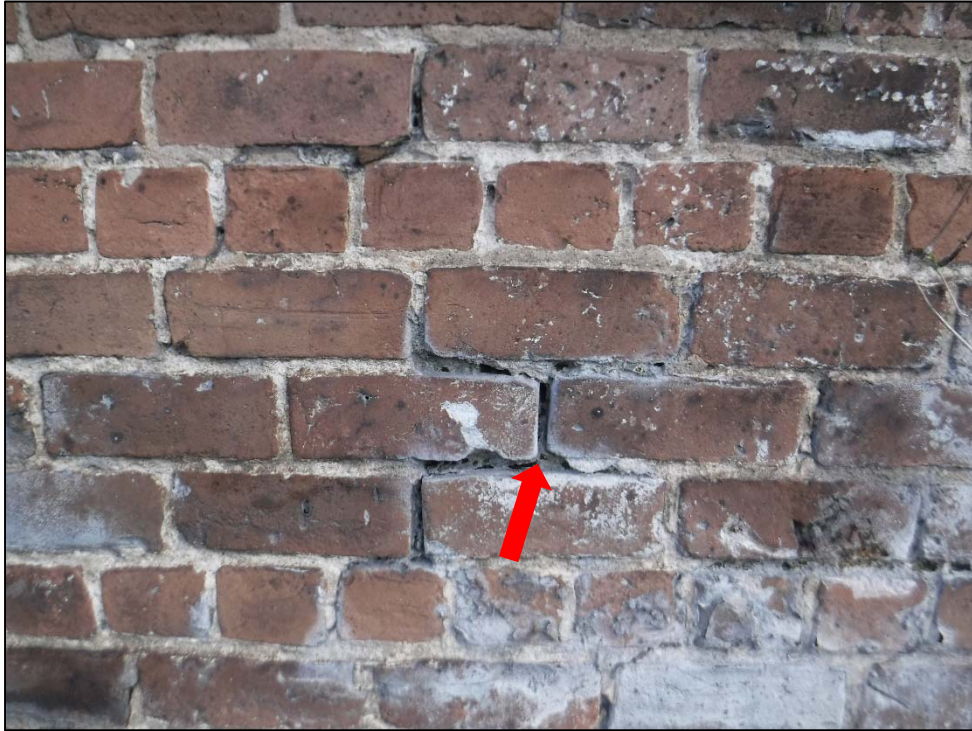
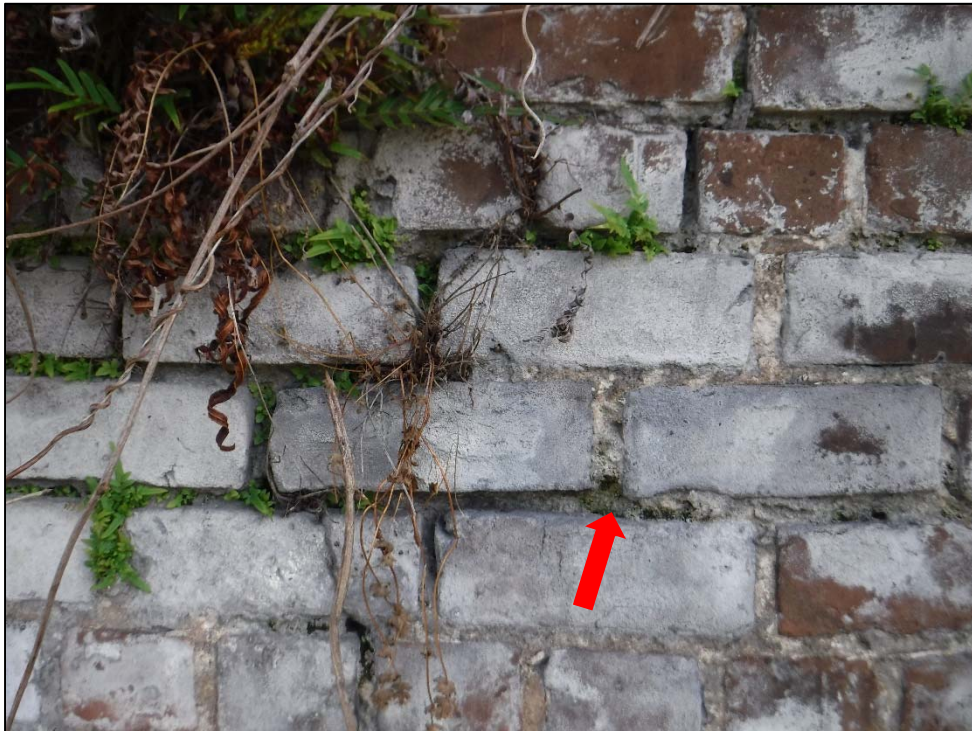
Photograph 99 – Deteriorated/Missing Mortar in Southwest Wingwall

Photograph 100 – Deteriorated/Missing Mortar in Southwest Wingwall

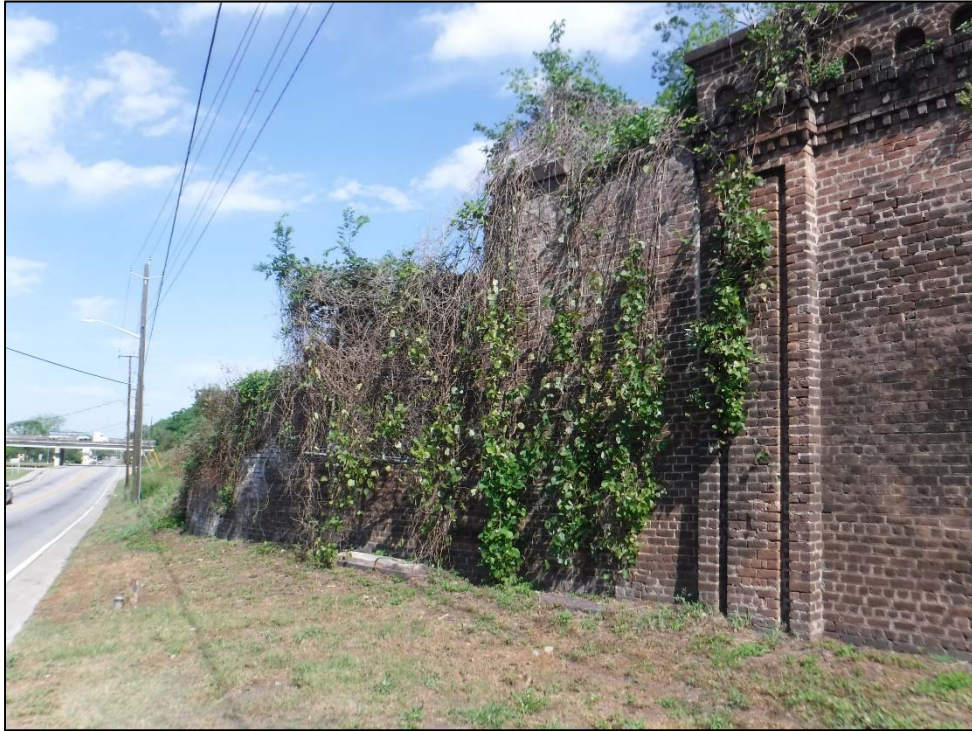
Photograph 101 – Vegetation Growth on Southwest Wingwall

8. The chain link fence at the west approach and the fallen fence section at the southwest wingwall should be removed.
  9. All components of the existing drainage system should be exposed and cleaned. Following topside masonry repairs, the system should be rehabilitated as follows:
