22 PRESERVATION BRIEFS

The Preservation and Repair of Historic Stucco

Anne Grimmer

U.S. Department of the Interior
National Park Service
Preservation Assistance Division

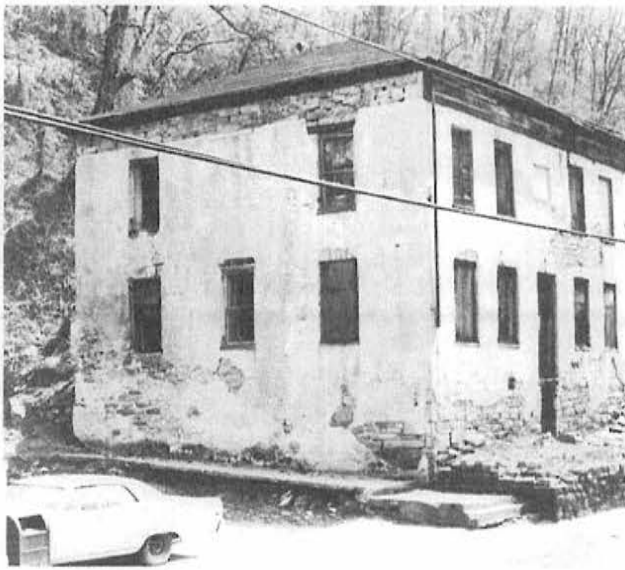
Fig. 7. Patches of stucco have fallen off this derelict 19th century structure exposing the rough-cut local stone substrate. The missing wood entablature on the side and the rough wood lintel now exposed above a second-floor window, offer clues that the building was stuccoed originally. Photo: National Park Service Files.

Stucco is applied directly, without lath, to masonry substrates such as brick, stone, concrete or hollow tile (Fig. 7). But on wood structures, stucco, like its interior counterpart plaster, must be applied over lath in order to obtain an adequate key to hold the stucco. Thus, when applied over a log structure, stucco is laid on horizontal wood lath that has been nailed on vertical wood furring strips attached to the logs (Fig. 8). If it is applied over a wood frame structure, stucco may be applied to wood or metal lath nailed directly to the wood frame; it may also be placed on lath that has been attached to furring strips. The furring strips are themselves laid over building paper covering the wood sheathing (Fig. 9). Wood lath was gradually superseded by expanded metal lath introduced in the late-nineteenth and early-twentieth century. When stuccoing over a stone or brick substrate, it was customary to cut back or rake out the mortar joints if they were not already recessed by natural weathering or

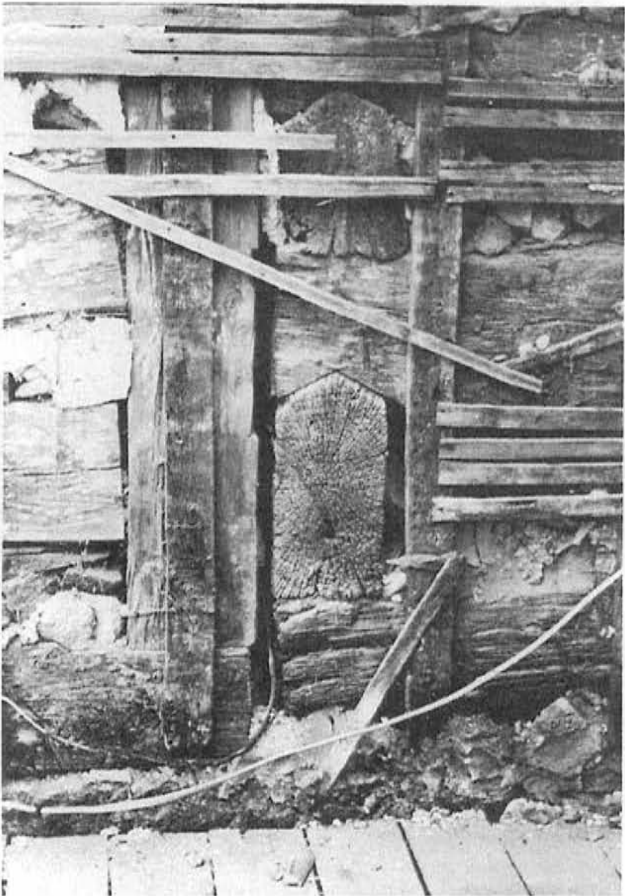
Fig. 8. Removal of deteriorated stucco in preparation for stucco repair on this late-18th century log house in Middleway, West Virginia, reveals that the stucco was applied to hand-riven wood lath nailed over vertical wood strips attached to the logs. Photo: Anne Grimmer.

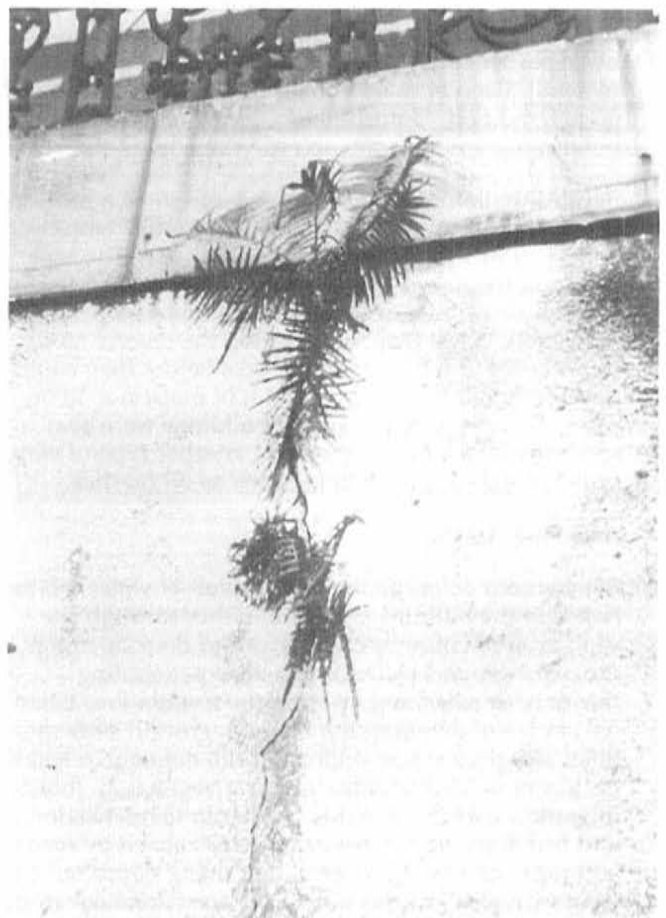
Fig. 12. (a) Water intrusion caused by rusting metal, or (b) plant growth left unattended will gradually enlarge these cracks, resulting in spalling, and eventually requiring extensive repair of the stucco. Photos: National Park Service Files.

repairs, external vibration caused by traffic or construction, or building settlement can also result in cracks which permit the entrance of water and cause the stucco to fail (Fig. 12).

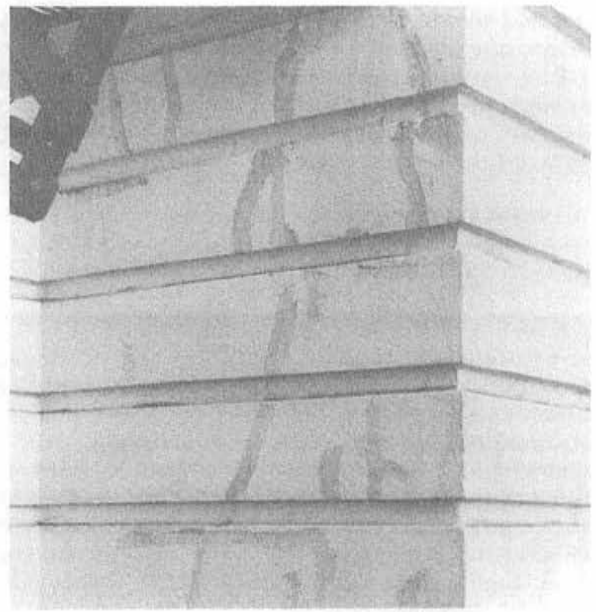
Fig. 13. (a) In preparation for repainting, hairline cracks on this Mediterranean style stucco apartment building were filled with a commercial caulking compound; (b) dirt is attracted and adheres to the texture of the caulked areas, and a year after painting, these inappropriate repairs are highly obvious. Photos: Anne Grimmer.

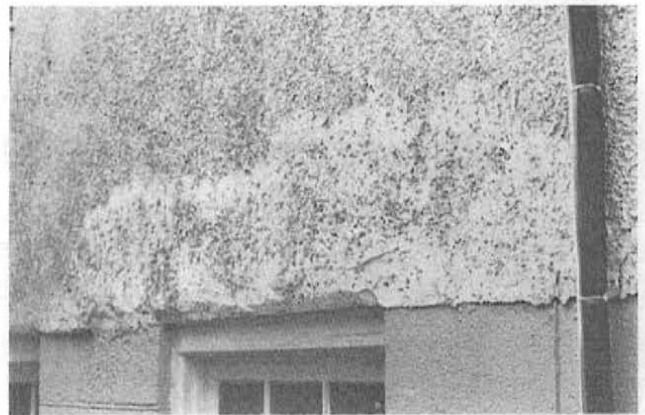
Fig. 14. This poorly executed patch is not the work of a professional plasterer. While it may serve to keep out water, it does not match the original surface, and is not an appropriate repair for historic stucco. Photo: Betsy Chittenden.

Once the extent of damage has been determined, a number of repair options may be considered. Small hairline cracks usually are not serious and may be sealed with a thin slurry coat consisting of the finish coat ingredients, or even with a coat of paint or white-wash. Commercially available caulking compounds are not suitable materials for patching hairline cracks. Because their consistency and texture is unlike that of stucco, they tend to weather differently, and attract more dirt; as a result, repairs made with caulking compounds may be highly visible, and unsightly (Fig. 13). Larger cracks will have to be cut out in preparation for more extensive repair. Most stucco repairs will require the skill and expertise of a professional plasterer (Fig. 14).

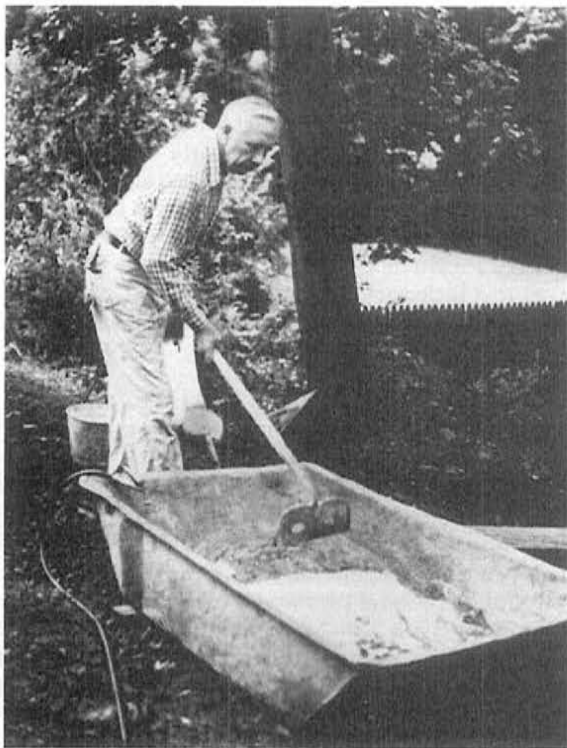
Fig. 16. (a) In preparation for stucco repair, this plasterer is mixing the dry materials in a mortar box with a mortar hoe (note the 2 holes in the blade), pulling it through the box using short choppy strokes. After the dry materials are thoroughly combined, water is added and mixed with them using the same choppy, but gradually lengthening stokes, making sure that the hoe cuts completely through the mix to the bottom of the box. (b) The deteriorated stucco has been cut away, and new metal lath has been nailed to the clapboarding in the area to be patched. (Although originally clapboarded when built in the 19th century, the house was stuccoed around the turn-of-the-century on metal lath nailed over the clapboard.) (c) The first, scratch coat and the second coat have been applied here, and await the spatterdash or rough-cast finish of the final coat (d) which was accomplished by the plasterer using a whisk broom to throw the stucco mortar against the wall surface. This well-executed patch is barely discernable, and lacks only a coat of paint to make it blend completely with the rest of the painted wall surface. Photos: Anne Grimmer.

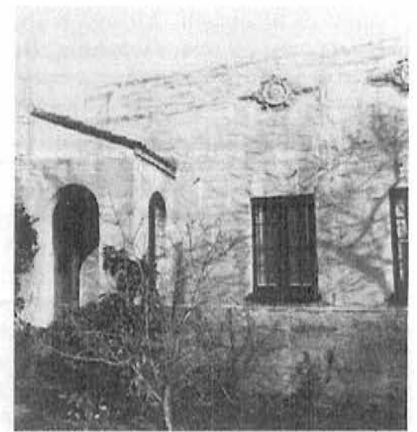
Most of the oldest stucco in the U.S. dating prior to the late-nineteenth century, will generally have a **smooth, troweled finish** (sometimes called a **sand or float finish**), possibly scored to resemble ashlar masonry units. Scoring may be incised to simulate masonry joints, the scored lines may be emphasized by black or white penciling, or the lines may simply be drawn or painted on the surface of the stucco. In some regions, at least as early as the first decades of the nineteenth century, it was not uncommon to use a **roughcast finish** on the foundation or base of an otherwise **smooth-surfaced** building (Fig. a). **Roughcast** was also used as an overall stucco finish for some outbuildings, and other less important types of structures.

A wide variety of decorative surface textures may be found on revival style stucco buildings, particularly residential architecture. These styles evolved in the late-nineteenth century and peaked in popularity in the early decades of the twentieth century. Frank Lloyd Wright favored a **smooth finish** stucco, which was imitated on much of the Prairie style architecture inspired by his work. Some of the more picturesque surface textures include: **English Cottage** or **English Cotswold** finish; **sponge finish** (Fig. b); **fan texture**; **adobe finish** (Fig. c), and **Spanish or Italian**

The most common early-twentieth century stucco finishes are often found on bungalow-style houses, and include: **spatter** or **spatterdash** (sometimes called **roughcast**, **harling**, or **wetdash**), and **pebbledash** or **drydash**. The **spatterdash** finish is applied by throwing the stucco mortar against the wall using a whisk broom or a stiff fiber brush, and it requires considerable skill on the part of the plasterer to achieve a consistently rough wall surface. The mortar used to obtain this texture is usually composed simply of a regular sand, lime, and cement mortar, although it may sometimes contain small pebbles or crushed stone aggregate, which replaces one-half the normal sand content. The **pebbledash** or **drydash** finish is accomplished manually by the plasterer throwing or "dashing" dry pebbles (about 1/8" to 1/4" in size), onto a coat of stucco freshly applied by another plasterer. The pebbles must be thrown at the wall with a scoop with sufficient force and skill that they will stick to the stuccoed wall. A more even or uniform surface can be achieved by patting the stones down with a wooden float. This finish may also be created using a texturing machine (Figs. d-f illustrate 3 versions of this finish. Photos: National Park Service Files).
