# CENTRAL OF GEORGIA RAILWAY VIADUCT ASSESSMENT

Inspection Date: April 14, 2020  
Submittal Date: May 8, 2020

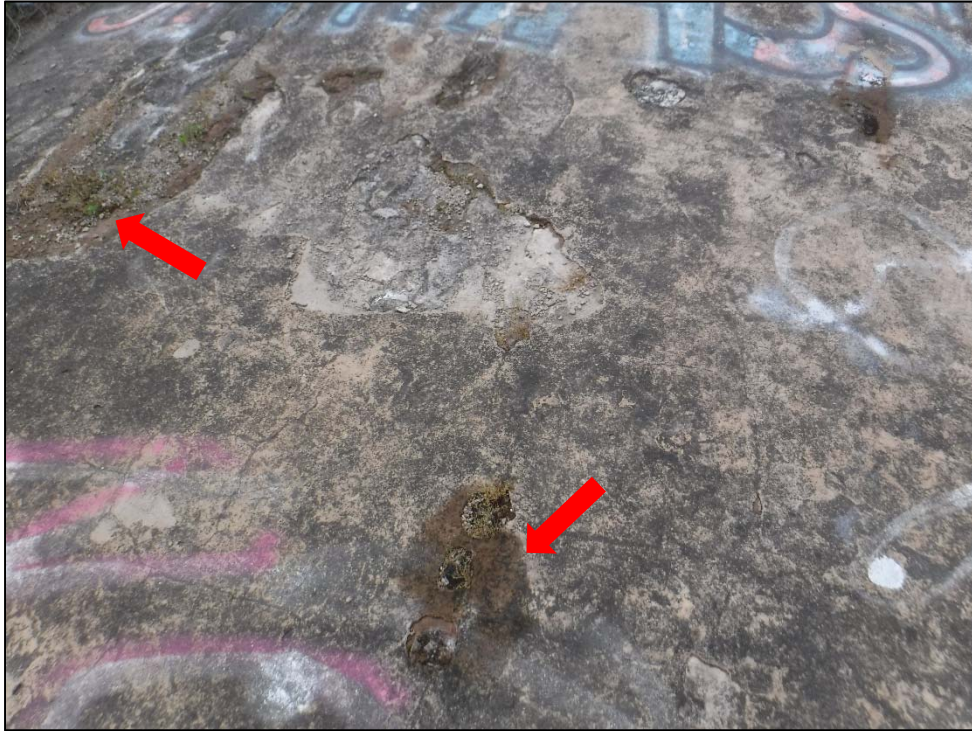
- The portions of Arches 3 and 4 which were exposed during previous fill removal were covered with mortar; up to 8-ft long by 3-ft wide sections of mortar were missing, exposing the brick masonry below. Light-to-moderate mortar loss and vegetation growth was observed at the exposed masonry. (Photograph 15)

Photograph 15 – Mortar Loss with Exposed Masonry and Vegetation Growth

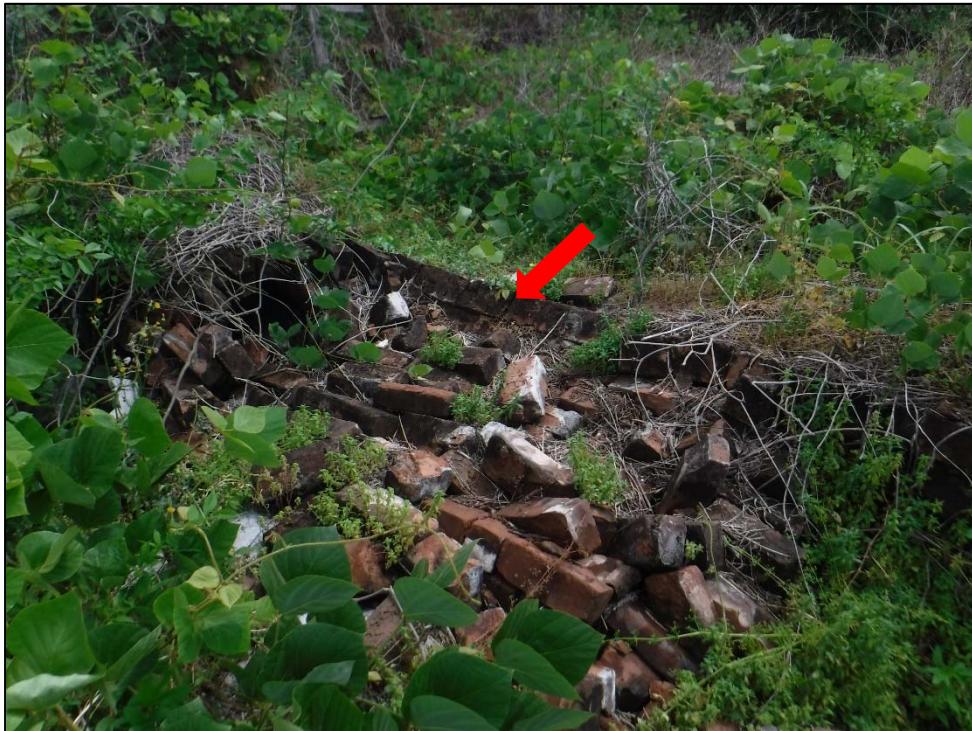
- Portions of the open drainage arches up to 6-ft long by the full width and height were collapsed at Piers 1 and 2. (Photographs 16, 17, and 18)
- Bowing up to 2-in high was observed along a 4-ft portion of the open drainage arch at Pier 3; the mortar joints were open and filled with debris. (Photograph 19)

Photograph 16 – Collapsed Portions of Open Drainage Arches

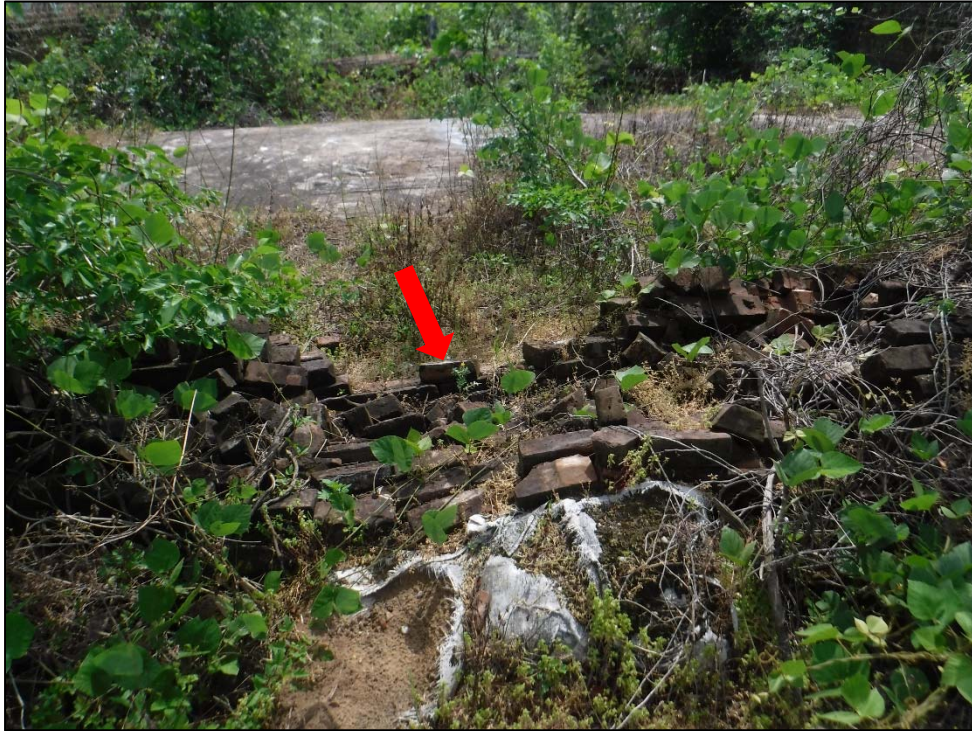
Photograph 17 – Collapsed Portions of Open Drainage Arches

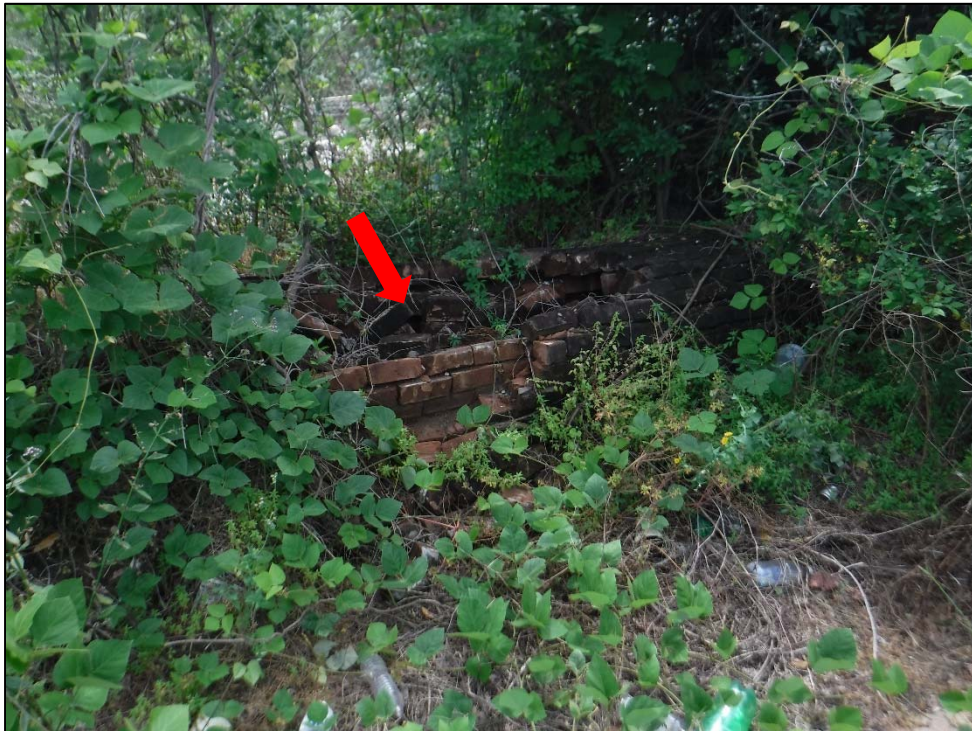
Photograph 18 – Collapsed Portions of Open Drainage Arches

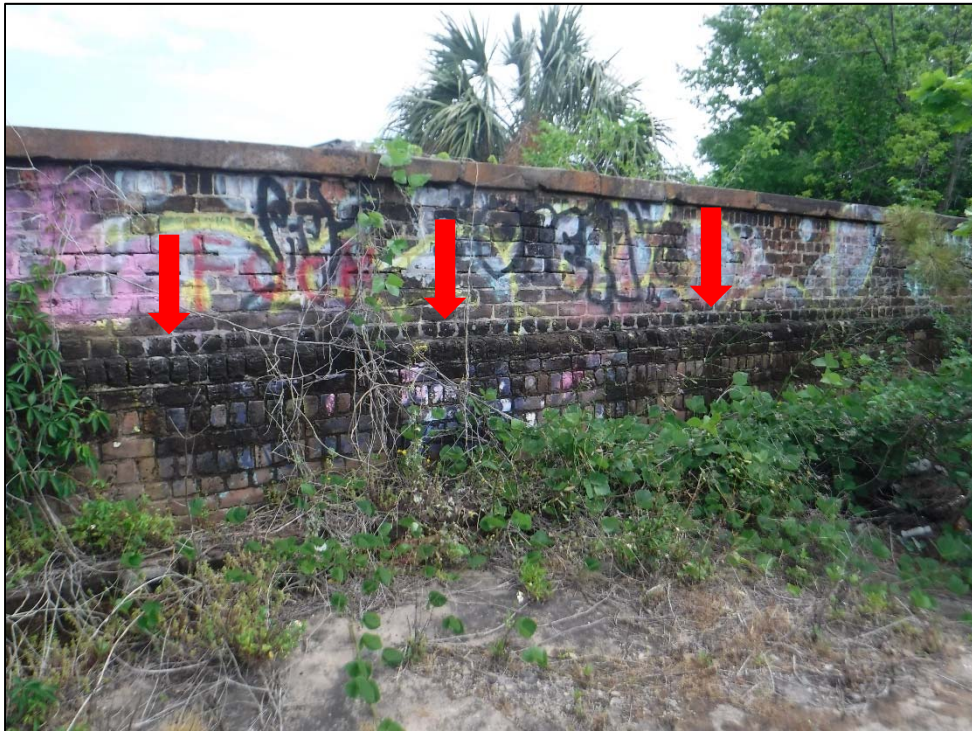
- It appears that up to 6-ft of fill has been removed from the top of the viaduct; the fill was reportedly removed as part of a previous repair program. (Photograph 20)

Photograph 20 – Fill Removed from Top of Viaduct

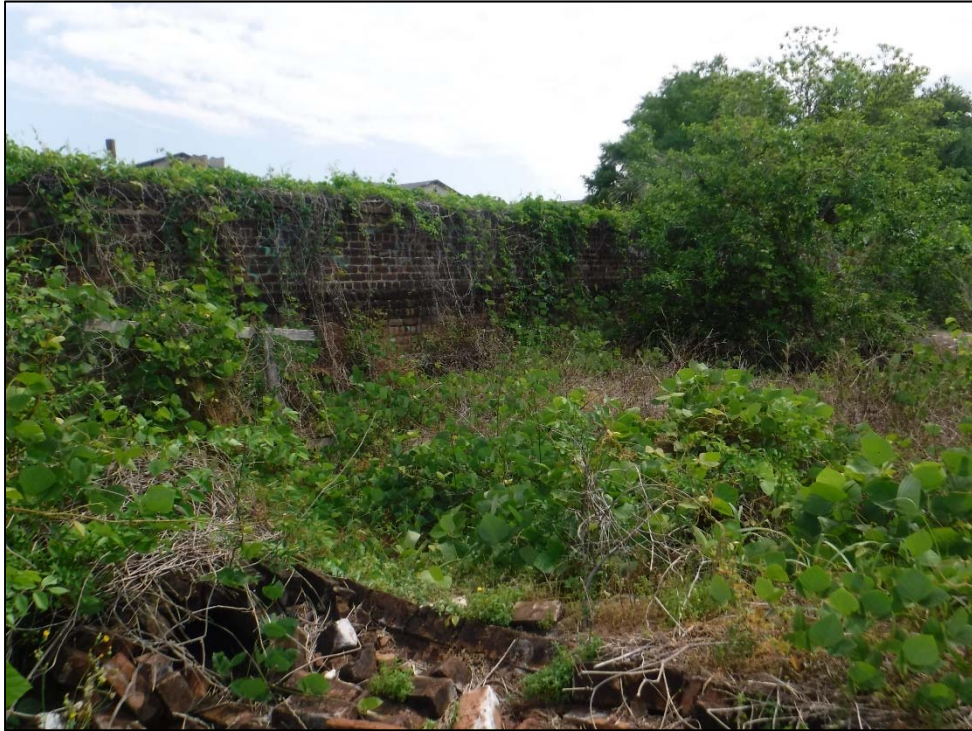
- Heavy vegetation growth was observed throughout the top of the viaduct. (Photograph 21)
- Graffiti was observed throughout the exposed brick masonry. (Photograph 22)

Photograph 21 – Heavy Vegetation Growth atop Viaduct

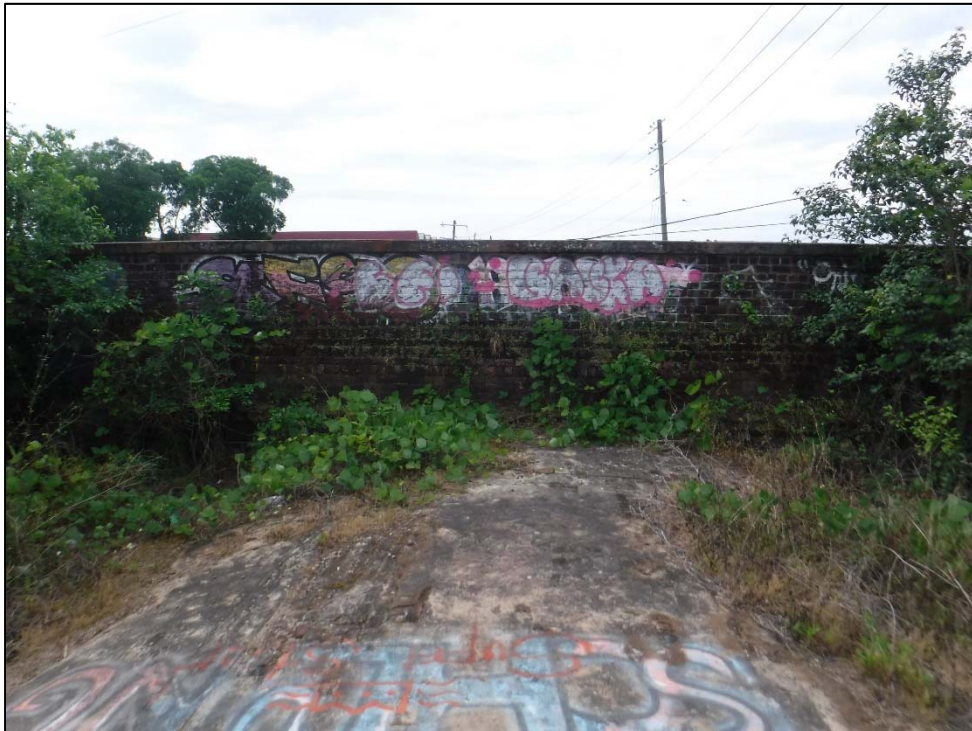
Photograph 22 – Graffiti on Brick Masonry

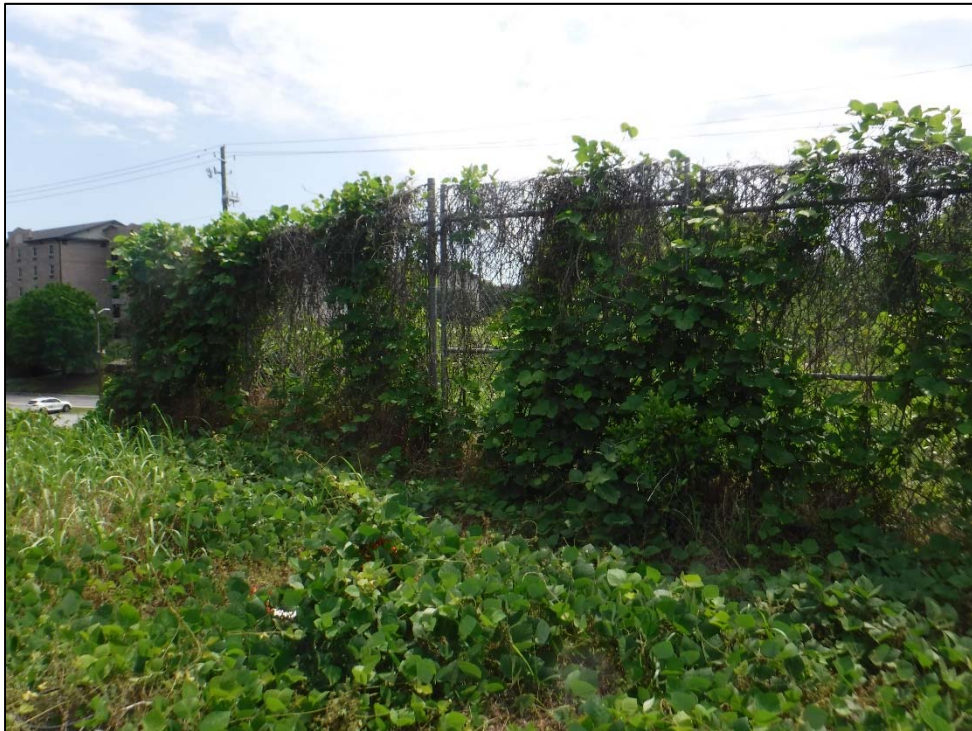
- A vagrant shelter was observed above Arch 4. (Photograph 23)
- The west approach of the viaduct was blocked by a chain link fence; the fence was covered with heavy vegetation growth. (Photograph 24)

Photograph 24 – Fence with Vegetation Growth Blocking West Approach

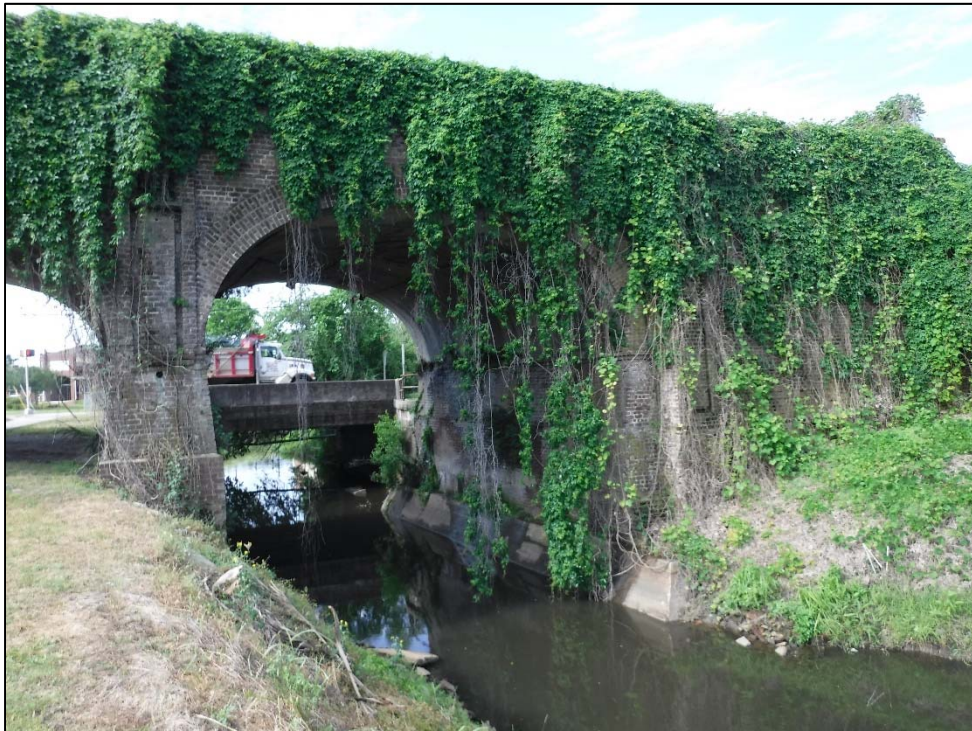
- 
- An area of missing brick up to 48-in high by 8-in wide by 8-in long was observed at the northwest corner of Pier 2. (Photograph 35)
  - Light-to-moderate vegetation growth was observed throughout the north elevation. (Photographs 36, 37, and 38)
  - One broken brick was observed east of Arch 4. (Photograph 39)
  - A crack gauge was previously installed at Arch 4. (Photograph 40)
  - Impact damage was observed at the guard rail protecting Pier 3. (Photograph 41)
  - Four stainless steel bolts were installed during a previous repair program above Arch 4. (Photographs 42 and 43)
  - “L” shaped stainless steel brackets up to 1/2-in thick by 6-in high by 33-in long were installed at the northeast corner of Arch 4 during a previous repair program. (Photograph 44)

Photograph 36 – Vegetation Growth Throughout North Elevation

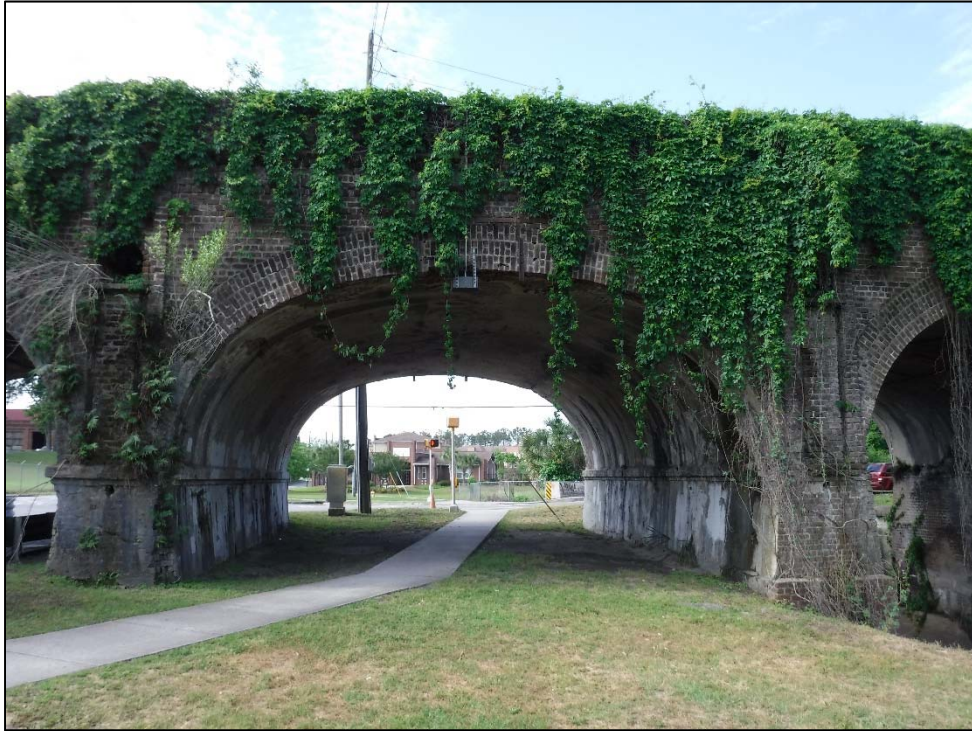
Photograph 37 – Vegetation Growth Throughout North Elevation

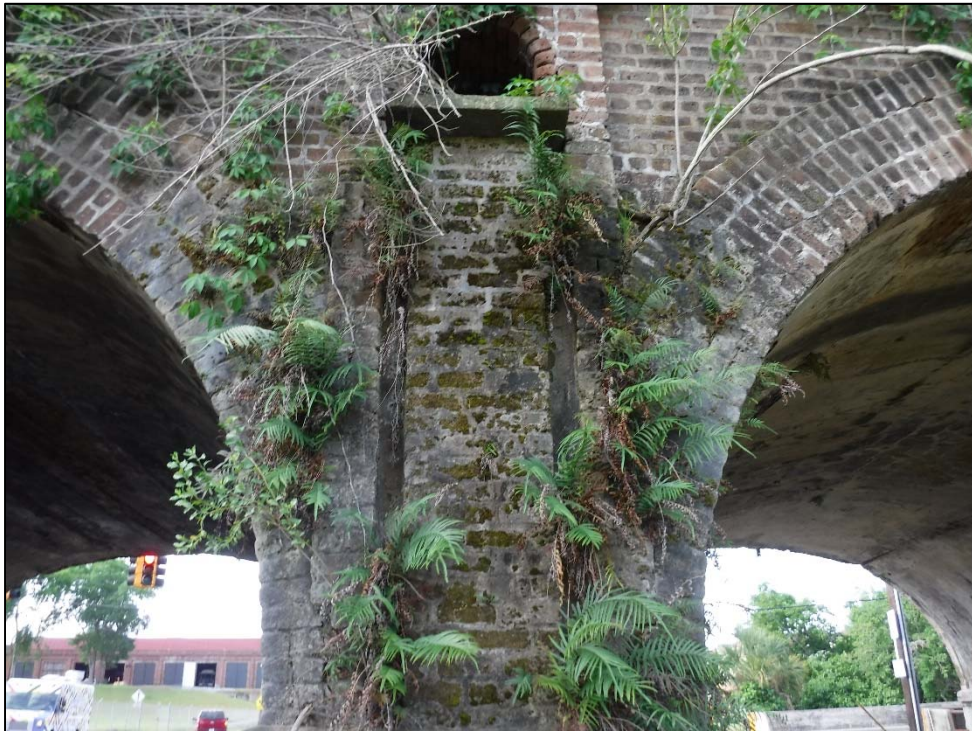
Photograph 38 – Vegetation Growth Throughout North Elevation

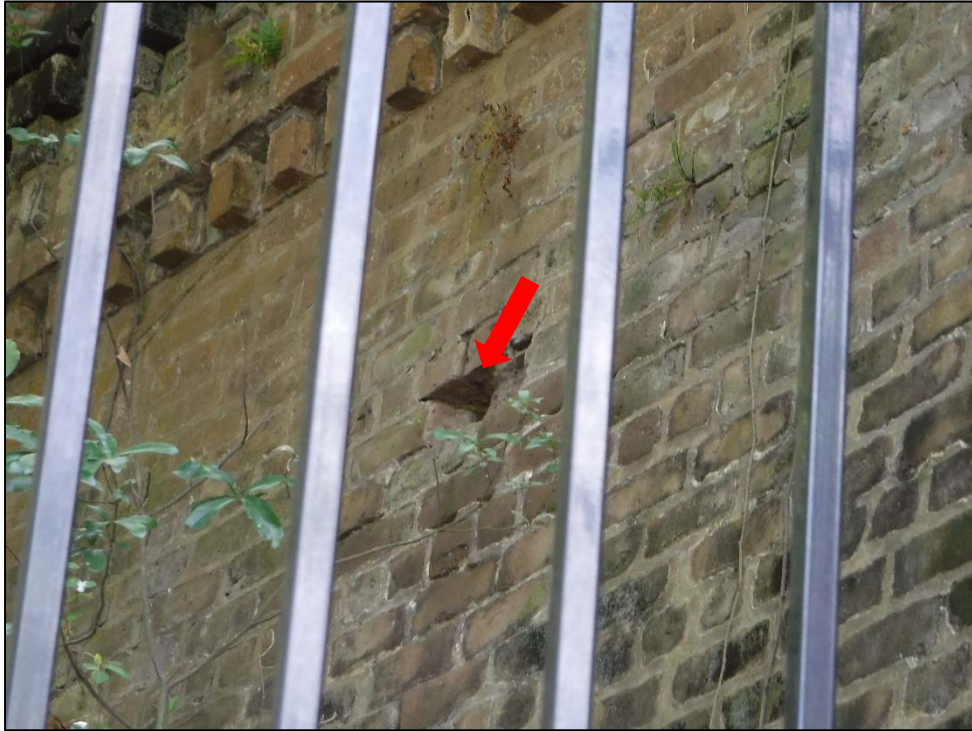
Photograph 39 – Broken Brick in Arch 4

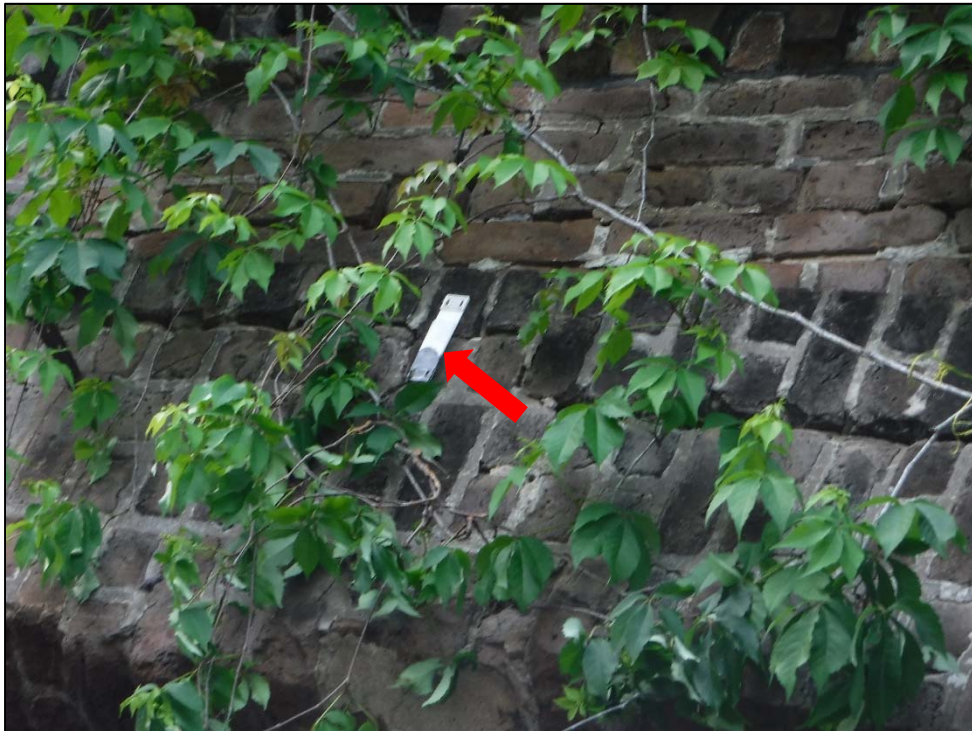
Photograph 40 – Crack Gauge at Arch 4

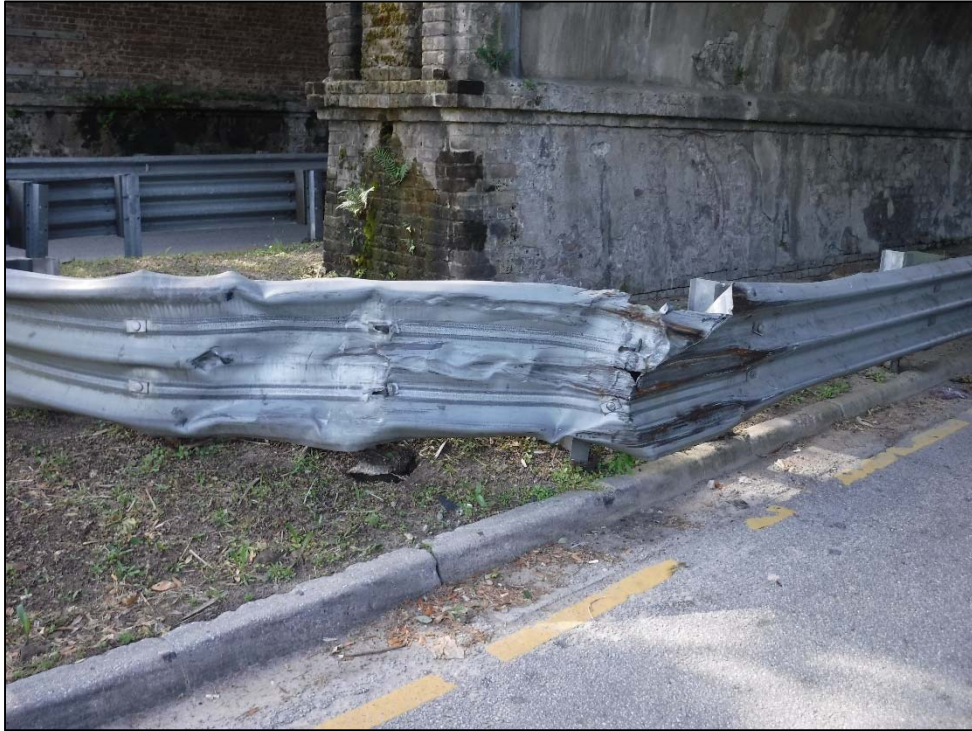
Photograph 41 – Guard Rail Impact Damage at Pier 3

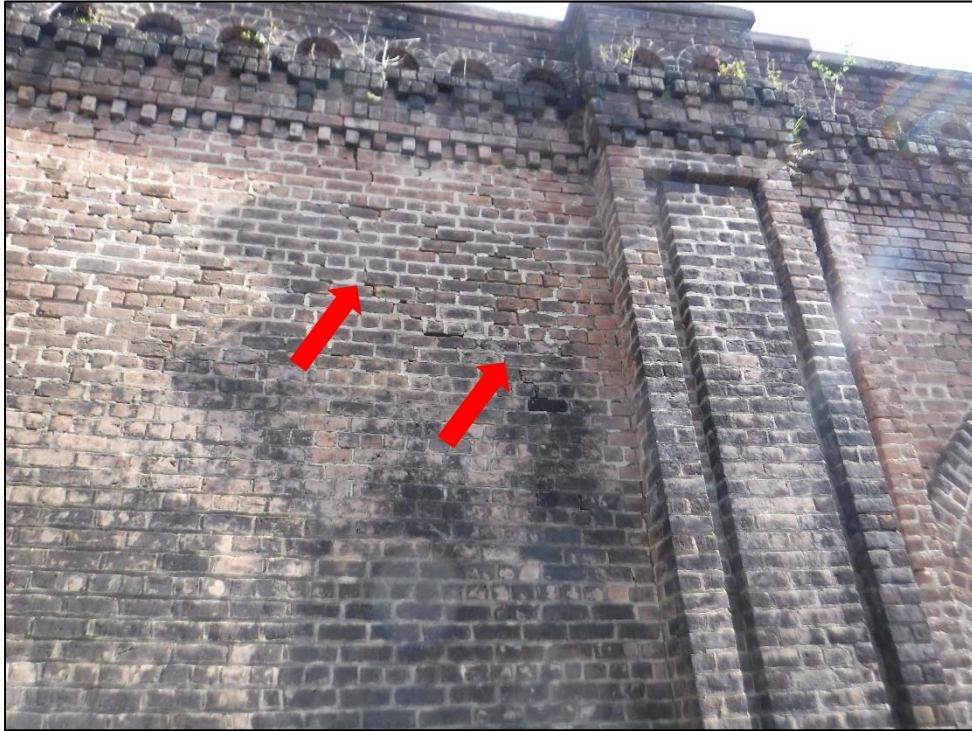
- A diagonal crack up to 1/4-in wide by 17-ft high with sixteen damaged/cracked bricks was observed in the brick masonry west of Arch 1; the crack propagates through the south face into the pier build-out. (Photographs 45 through 49)

Photograph 45 – Crack with Damaged Bricks

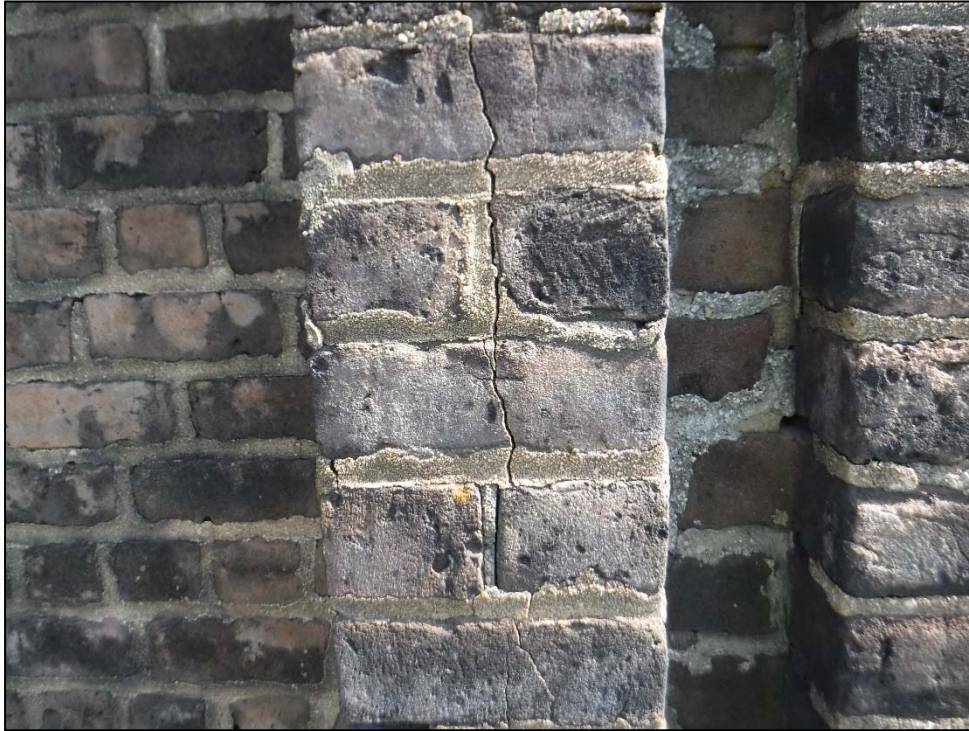
Photograph 49 – Crack with Damaged Bricks

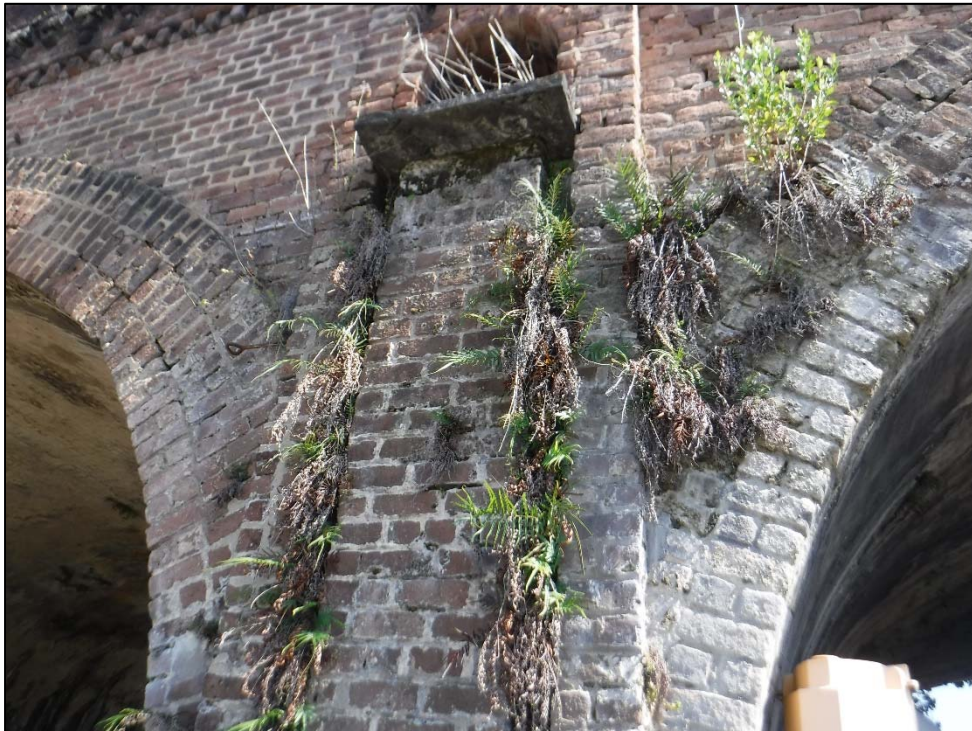
- Light vegetation growth was observed throughout the south elevation. (Photograph 60).
  - Open mortar joints were observed throughout the brick masonry. (Photograph 61)

Photograph 60 – Vegetation Growth at South Elevation

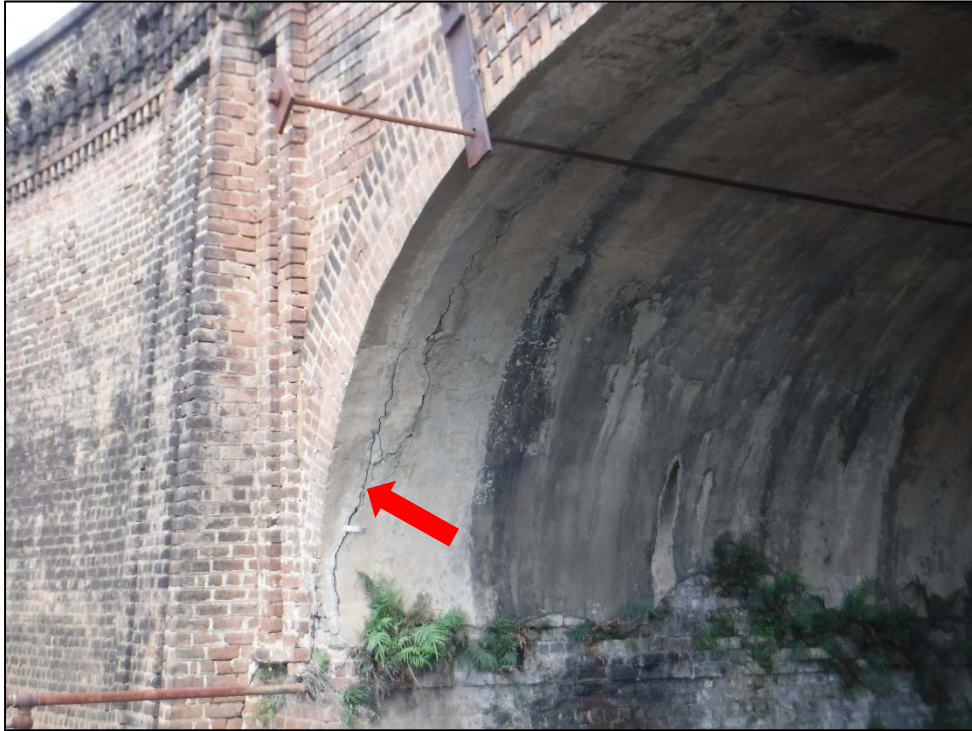
- A crack up to 1/2-in wide propagates across the full underside of the barrel of the arch. The crack initiates at the buildout at each side of the opening at the north face approximately 2-ft from the south end of the archway. The crack connects to the crack in the west buildout mentioned in Section 2.2. (Photographs 69 and 70)
- A crack up to 1/2-in wide propagates across the full underside of the barrel of the arch. The crack initiates at the buildout at each side of the opening at the north face approximately 8-ft from the north end of the archway. Spalled mortar up to 3-ft long by 2-ft wide by 3-in deep was observed along the crack; a crack gauge was installed adjacent to the spall during a previous repair program. (Photographs 71 through 74)

Photograph 69 – Crack Across Underside of Arch 1

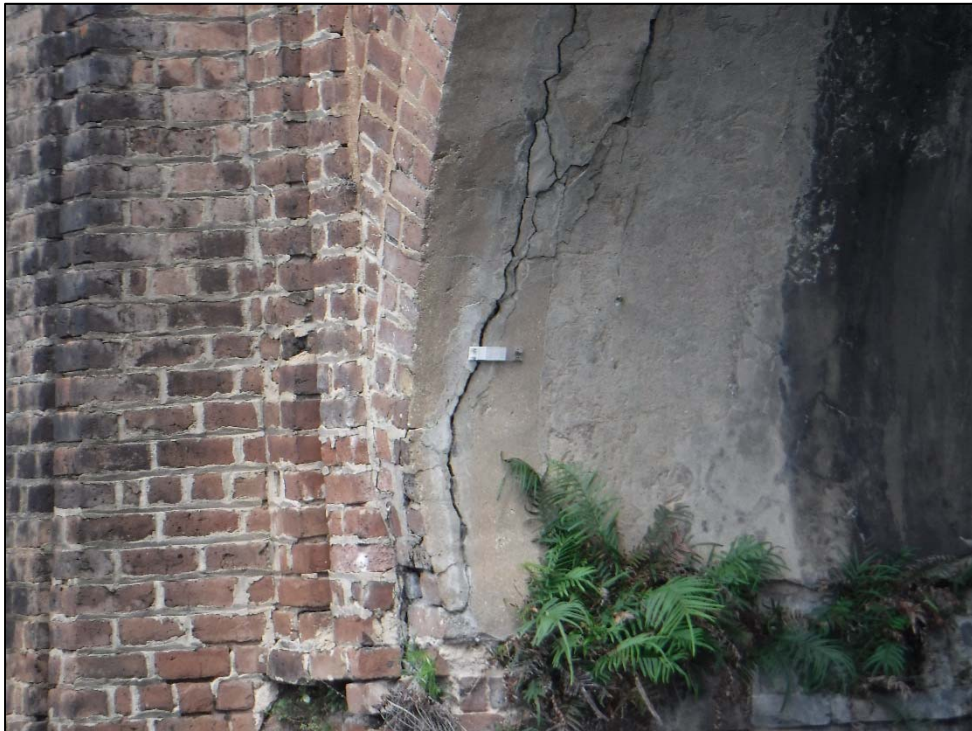
Photograph 70 – Crack Across Underside of Arch 1

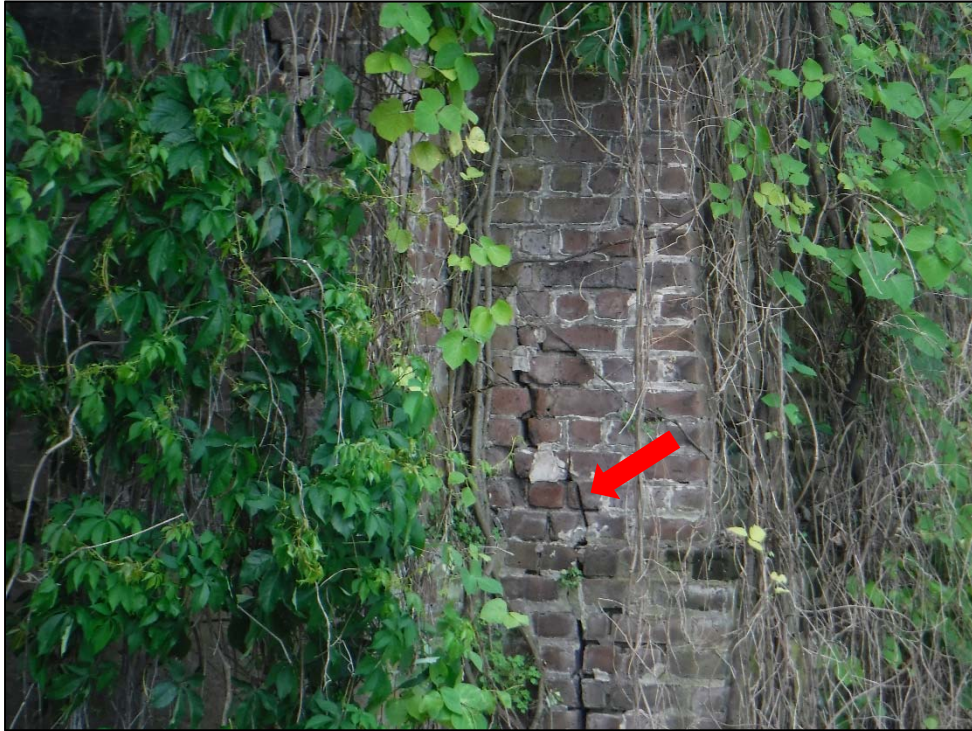
Photograph 71 – Crack with Spalled Mortar in Arch 1

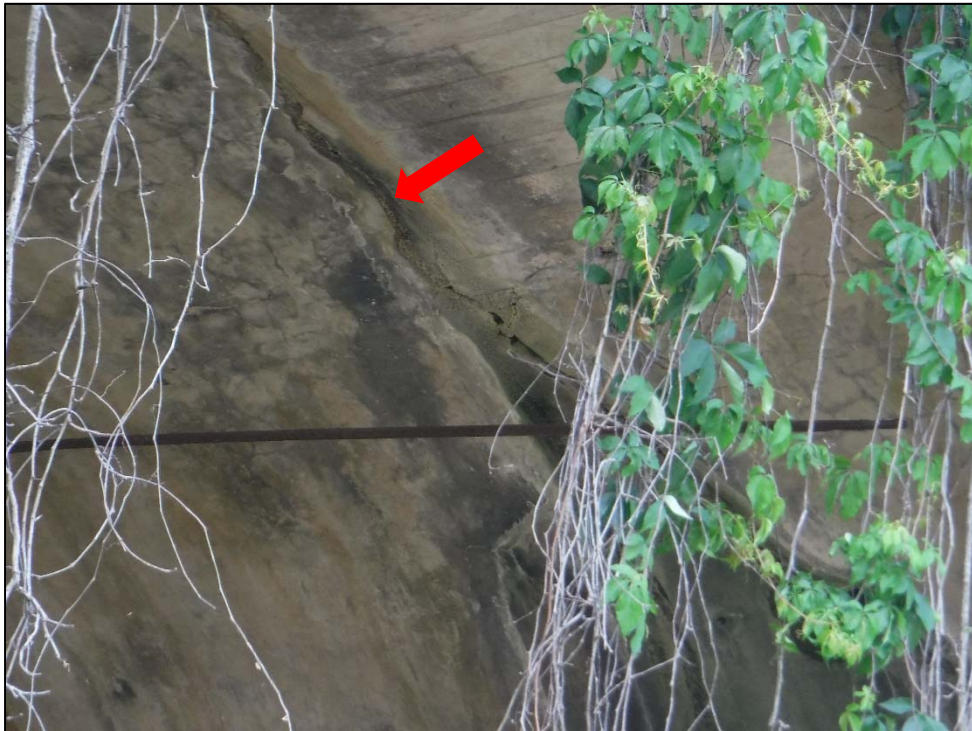
Photograph 72 – Crack with Spalled Mortar in Arch 1

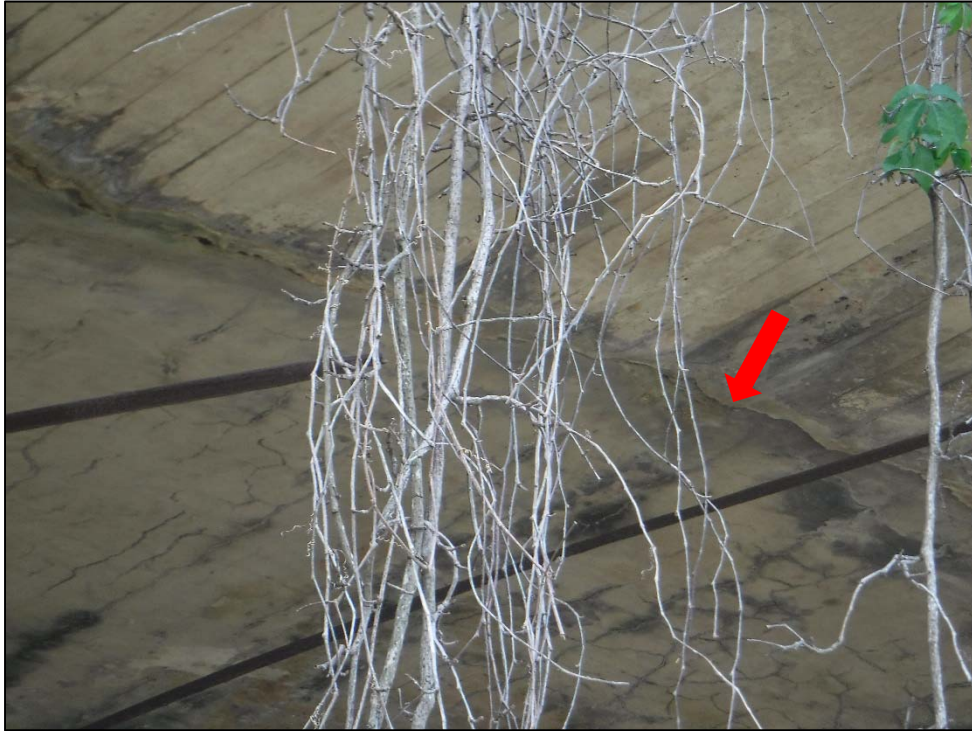
- 
- Three post-tensioning tie rods were installed across the full width of the arch; the rods appear to have been installed during a previous repair program and have subsequently failed. (Photographs 75, 76, and 77)
  - The underside of the brick masonry arch was covered with mortar; map cracking was observed throughout. (Photograph 73)

Photograph 73 – Crack with Spalled Mortar in Arch 1

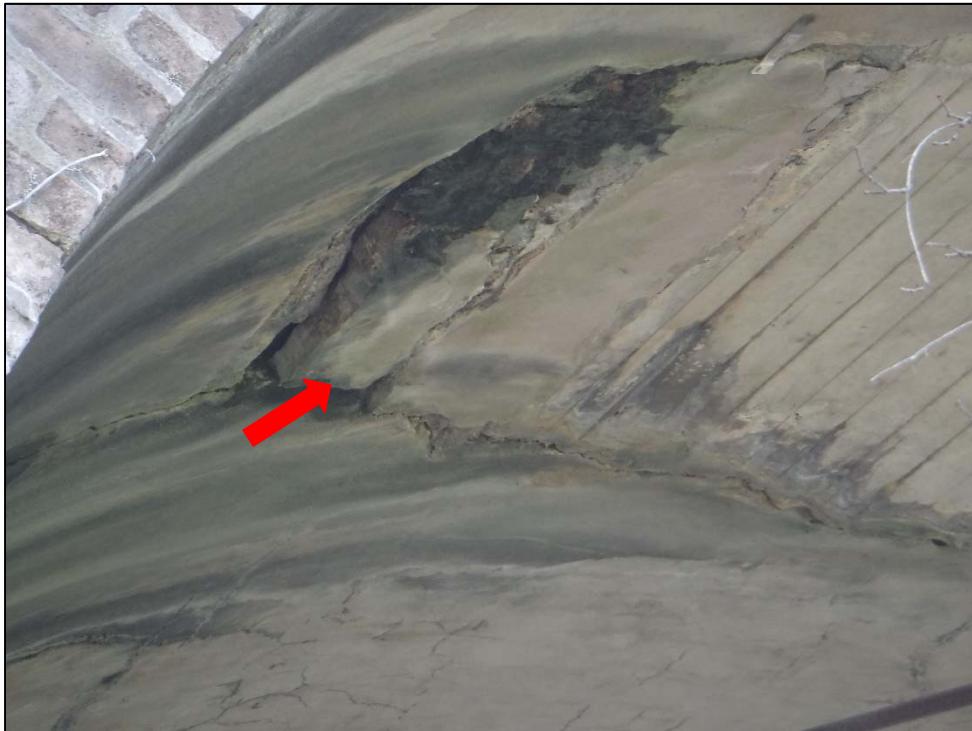
Photograph 74 – Crack with Spalled Mortar in Arch 1

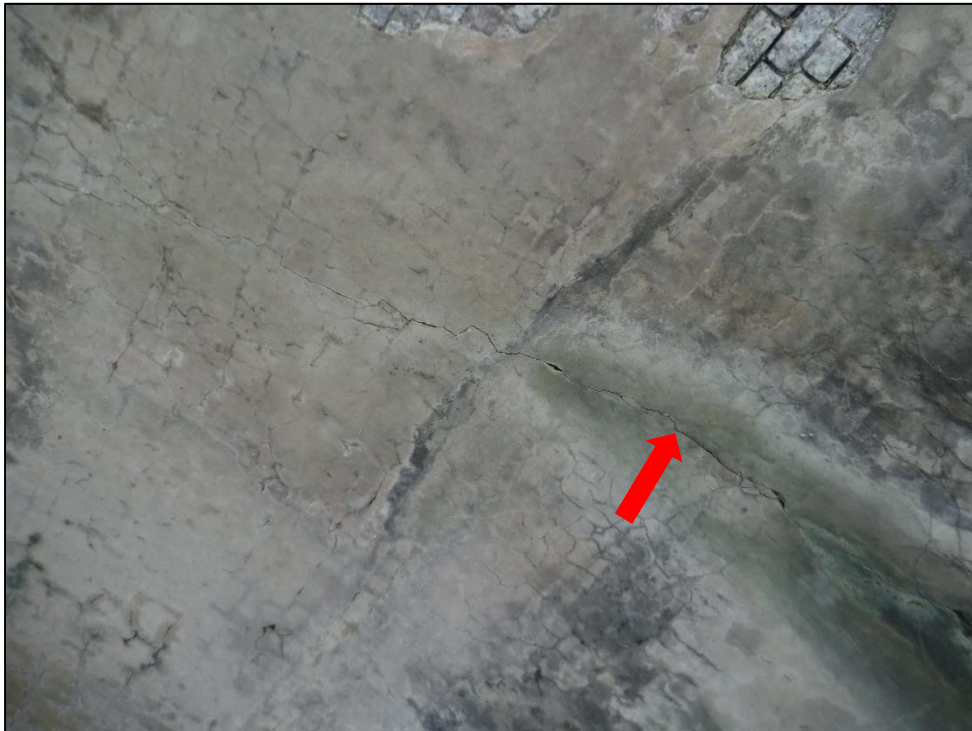
- A crack up to 1/2-in wide propagates across the full underside of the barrel of the arch approximately 6-ft from the north edge of the arch. (Photograph 78)
- Water was actively seeping from the mortar cracks at numerous locations at the underside of the arch. (Photograph 79)
- Spalled mortar up to 6-ft long by 4-ft wide was observed at the underside of the arch. (Photographs 80 and 81)
- The underside of the brick masonry arch was covered with mortar; map cracking was observed throughout. (Photograph 82)

Photograph 78 – Crack Across Underside of Arch 2

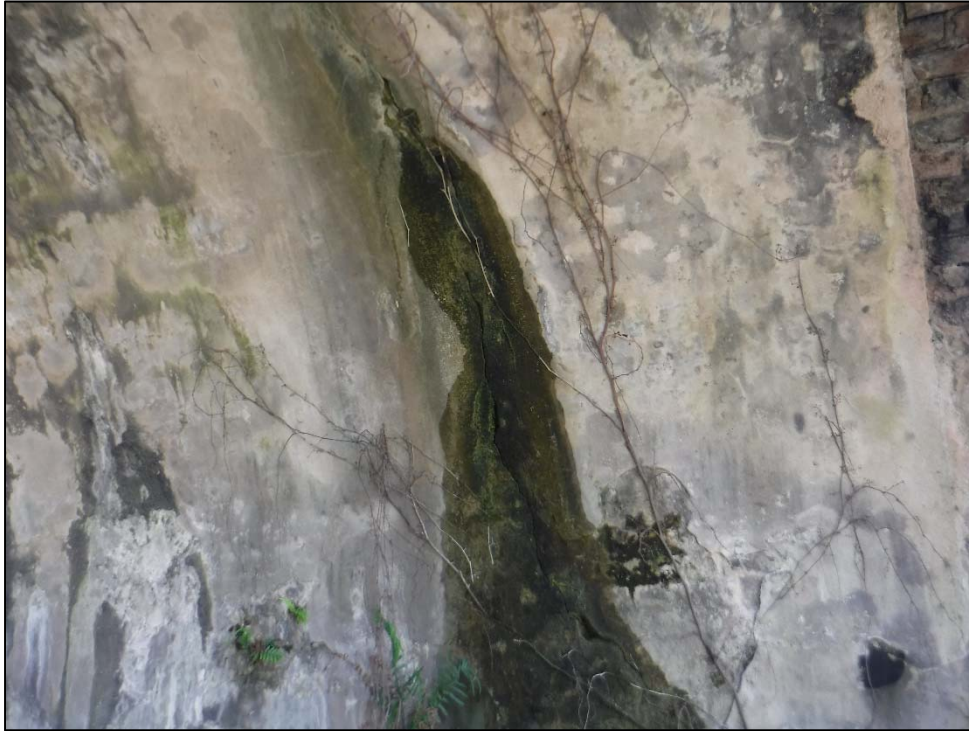
Photograph 79 – Active Water Seepage Through Mortar Cracks in Arch 2

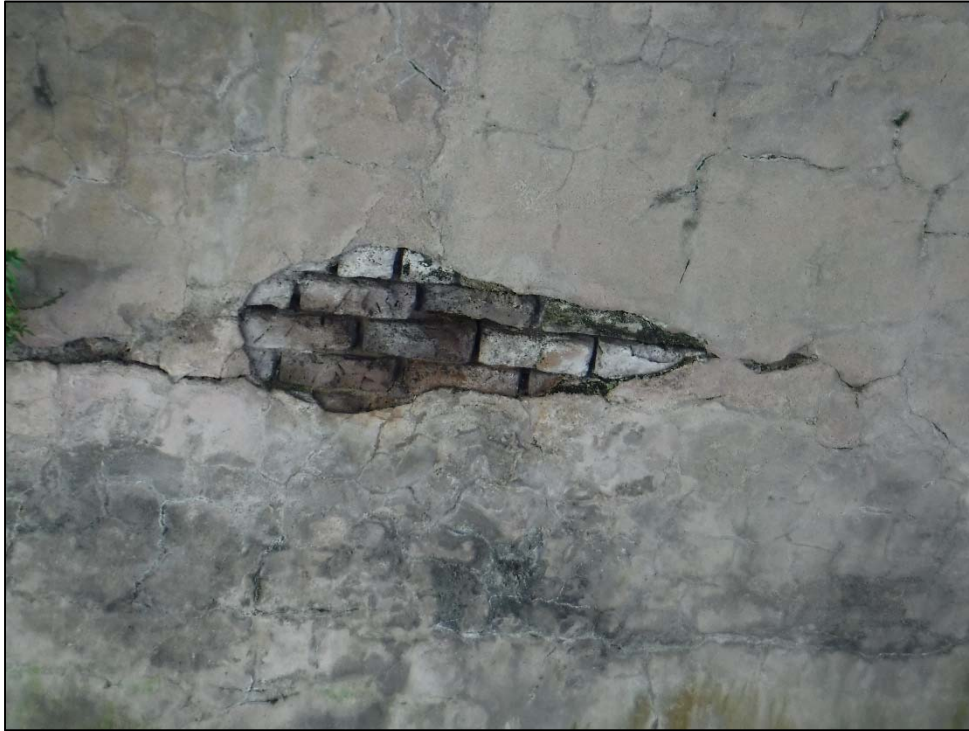
Photograph 81 – Spalled Mortar in Arch 2

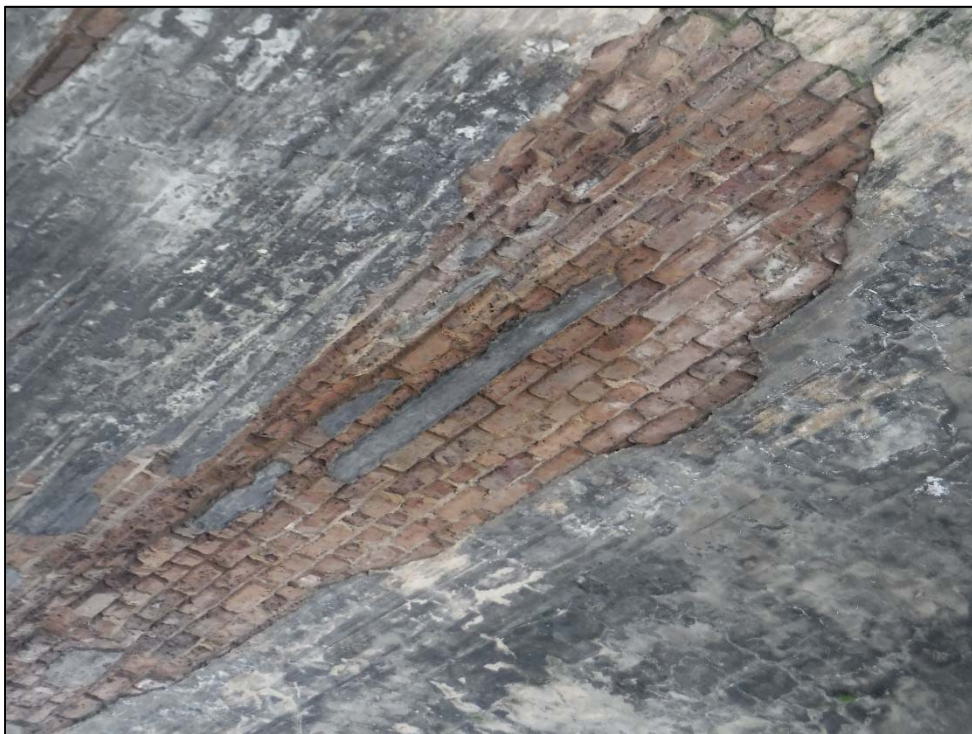
- An area of spalled mortar up to 30-ft long by 3-ft wide was observed along the apex of the arch. (Photographs 83 and 84)
- The underside of the brick masonry arch was covered with mortar; map cracking was observed throughout. (Photograph 85)

Photograph 84 – Spalled Mortar in Arch 3

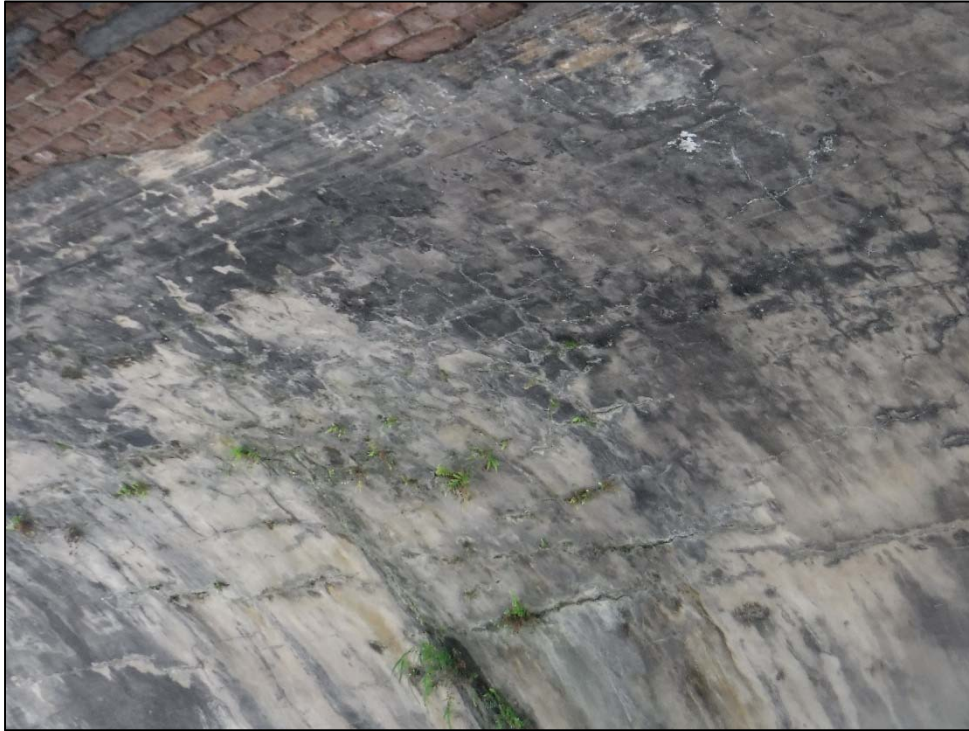
Photograph 85 – Map Cracking in Mortar in Arch 3

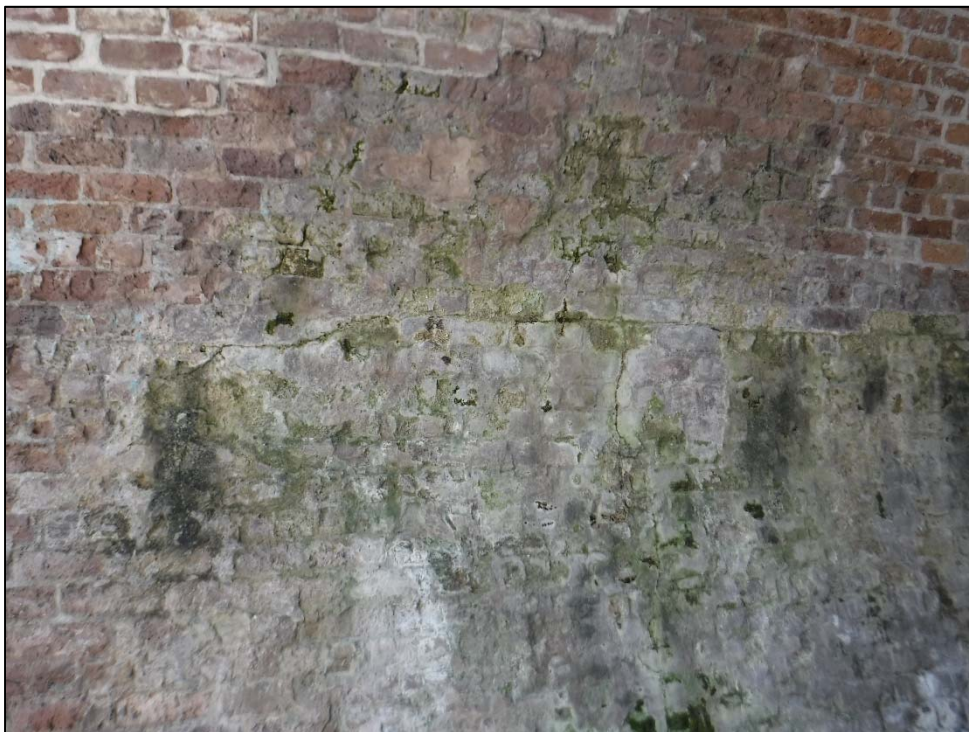
- Longitudinal and transverse cracking up to 1/8-in wide was observed on the underside of the arch approximately 8-ft from the south edge. (Photograph 86)

Photograph 86 – Longitudinal and Transverse Cracking in Arch 4

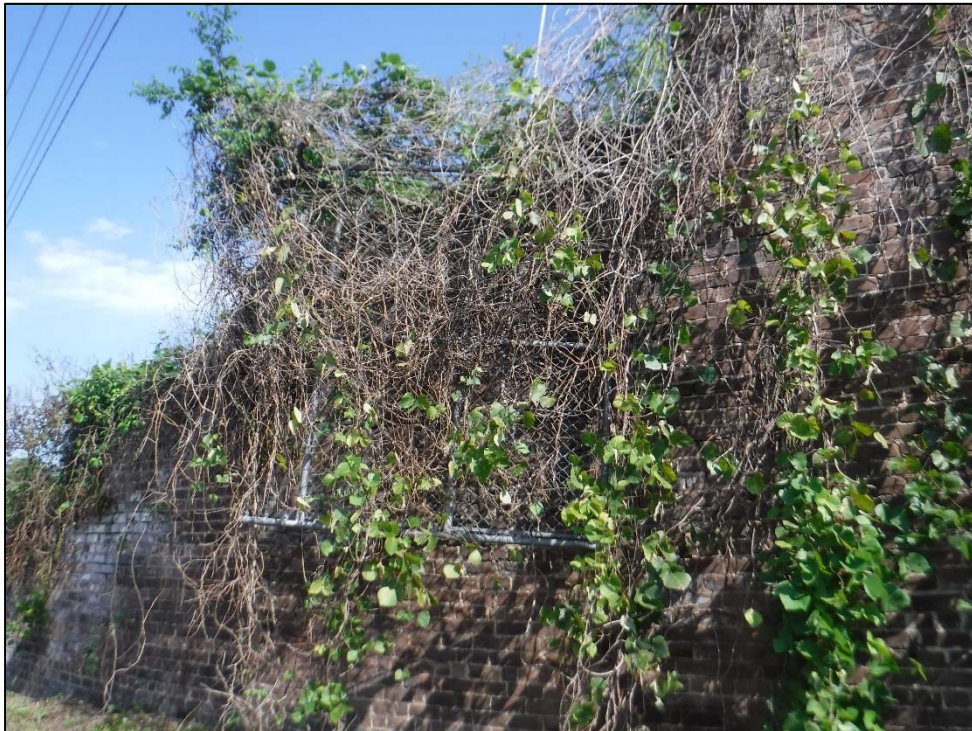
- Light-to-moderate vegetation growth was observed throughout; a section of chain link fence appears to have fallen and become entangled in the vegetation in front of the wall. (Photographs 101 and 102)
- One coping piece was dislodged from the top of the wall and was resting on grade at the base of the wall. (Photographs 103 and 104)

Photograph 102 – Fallen Fence in Vegetation Growth at Southwest Wingwall
