# CENTRAL OF GEORGIA RAILWAY VIADUCT ASSESSMENT

Inspection Date: April 14, 2020  
Submittal Date: May 8, 2020

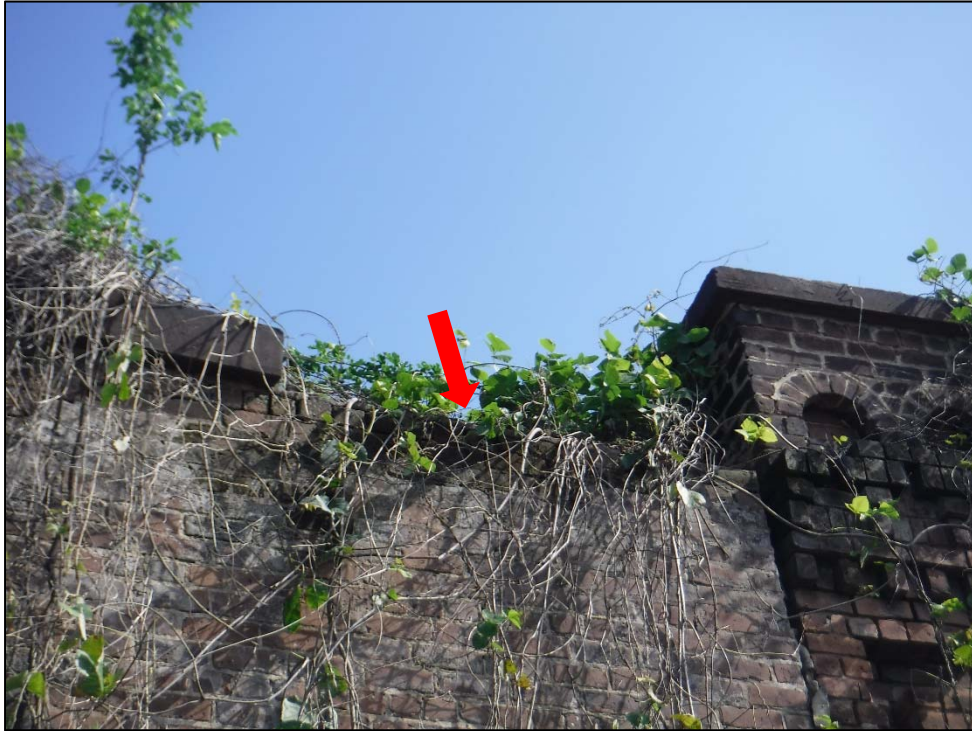
- Light-to-moderate vegetation growth was observed throughout; a section of chain link fence appears to have fallen and become entangled in the vegetation in front of the wall. (Photographs 101 and 102)
- One coping piece was dislodged from the top of the wall and was resting on grade at the base of the wall. (Photographs 103 and 104)

Photograph 103 – Dislodged Coping Piece at Southwest Wingwall

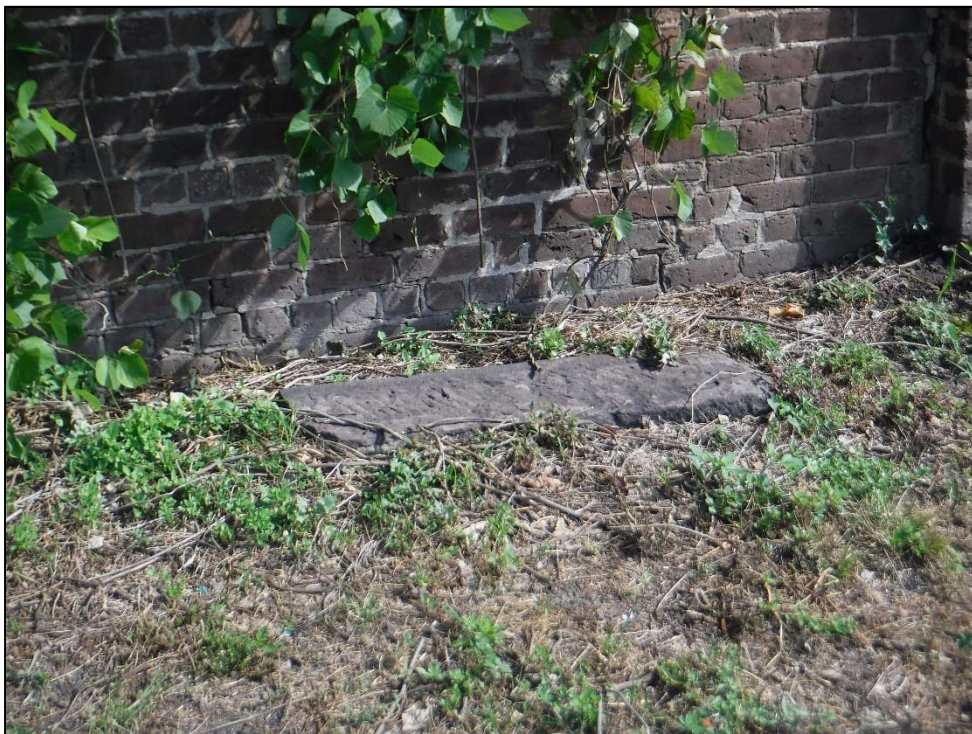
Photograph 104 – Dislodged Coping Piece at Southwest Wingwall
