# CENTRAL OF GEORGIA RAILWAY VIADUCT ASSESSMENT

Inspection Date: April 14, 2020  
Submittal Date: May 8, 2020

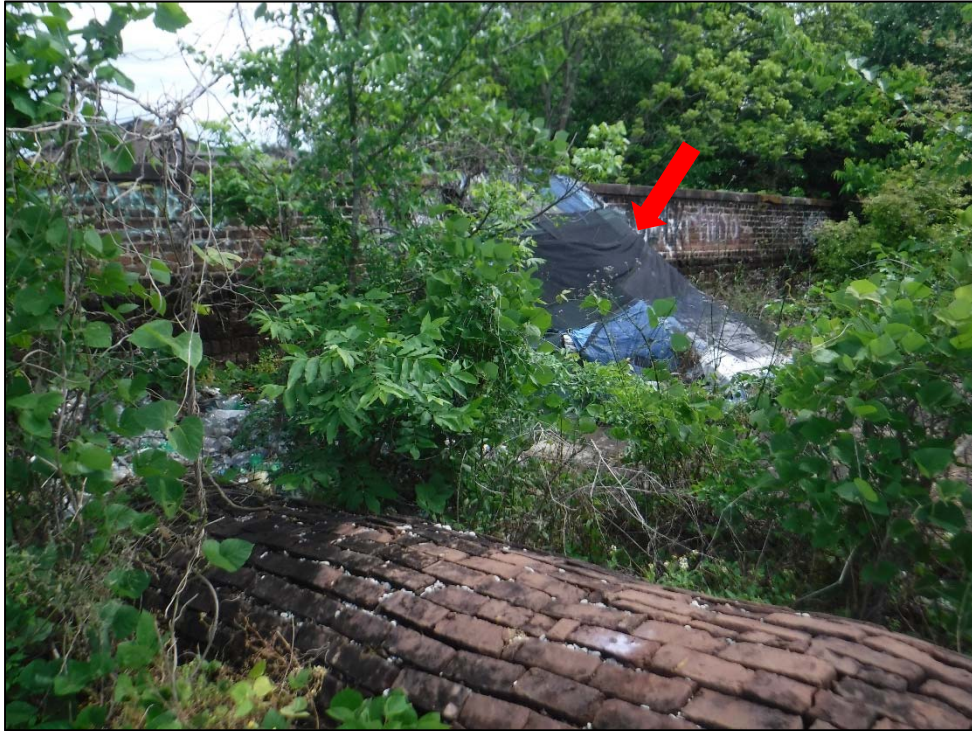
- A vagrant shelter was observed above Arch 4. (Photograph 23)
- The west approach of the viaduct was blocked by a chain link fence; the fence was covered with heavy vegetation growth. (Photograph 24)

Photograph 23 – Vagrant Shelter

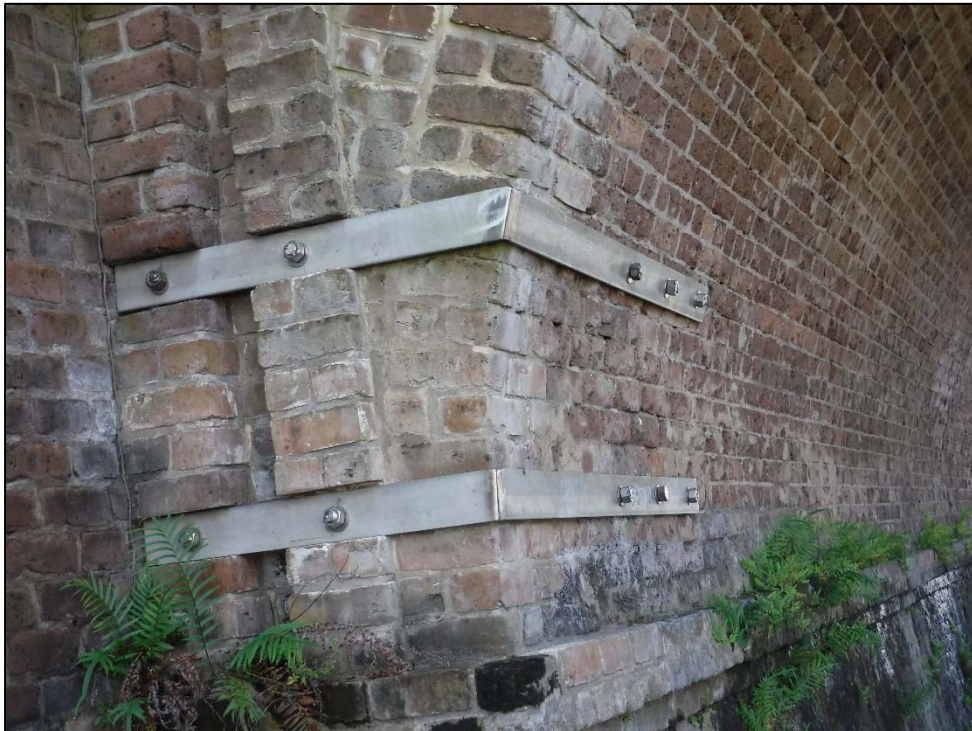
- 
- An area of missing brick up to 48-in high by 8-in wide by 8-in long was observed at the northwest corner of Pier 2. (Photograph 35)
  - Light-to-moderate vegetation growth was observed throughout the north elevation. (Photographs 36, 37, and 38)
  - One broken brick was observed east of Arch 4. (Photograph 39)
  - A crack gauge was previously installed at Arch 4. (Photograph 40)
  - Impact damage was observed at the guard rail protecting Pier 3. (Photograph 41)
  - Four stainless steel bolts were installed during a previous repair program above Arch 4. (Photographs 42 and 43)
  - “L” shaped stainless steel brackets up to 1/2-in thick by 6-in high by 33-in long were installed at the northeast corner of Arch 4 during a previous repair program. (Photograph 44)

Photograph 44 – Stainless Steel Brackets at Arch 4
